METRO TAC AGENDA
(Technical Advisory Committee to Metro JPA)

3. **REPORT:** Update from Residuals Management Working Group (Padre Dam MWD)
 4. **PRESENTATION:** Summary of April 10, 2020 City of San Diego Sanitary Sewer Overflow Incident (Tom Rosales/Dean Gipson HDR) (**Attachment**)

Subject: Notice of Violation No. R9-2020-0204 and Investigative Order No. R9-2020-0205 for the Reported April 10, 2020 Unauthorized Discharge to Sweetwater River - Written Responses

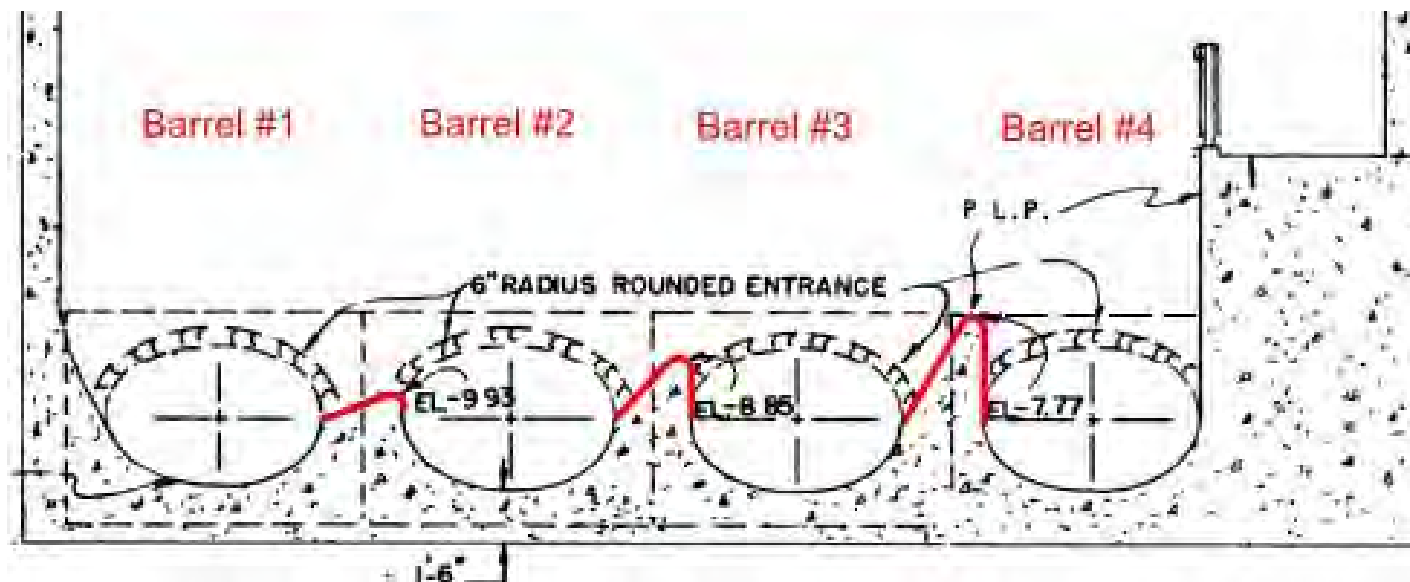
Cross Section of Sweetwater River Siphons

- Elliptical pipes flow under the Sweetwater River
- Blockage removed from Barrel #2

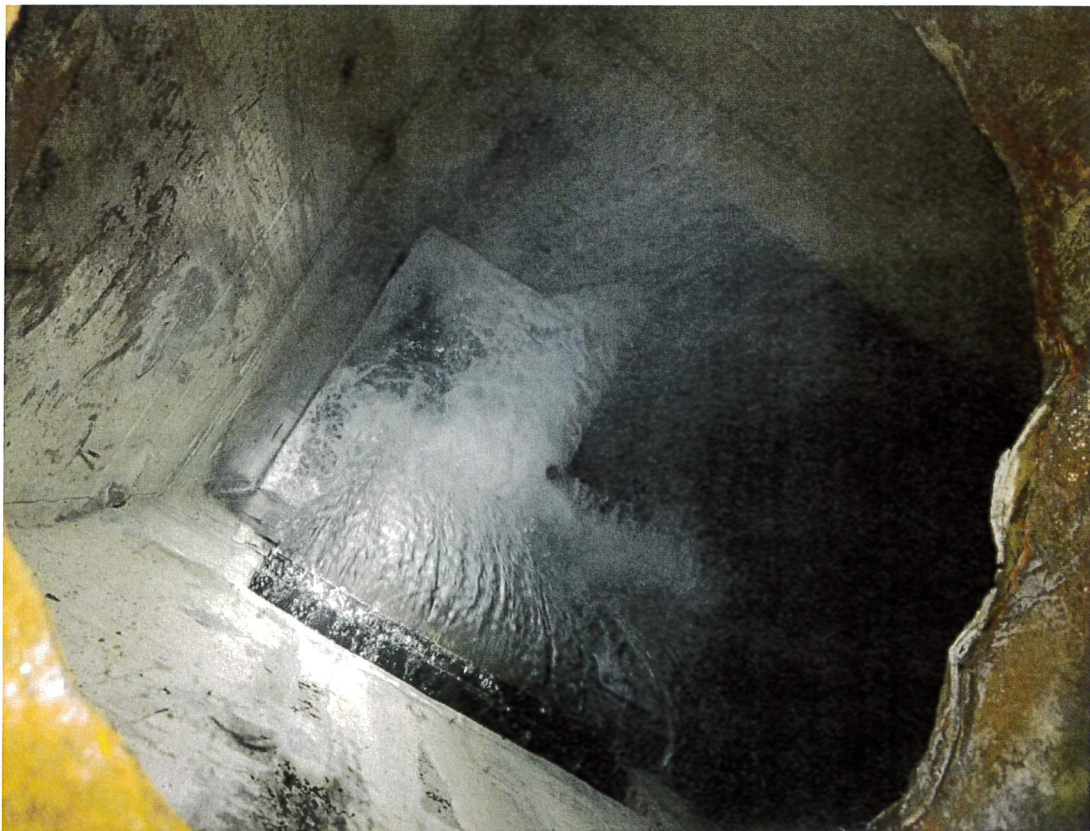
Figure 5. Interior of the South SMI Siphon Transition Structure on July 7, 2020 around 11:59 pm (FSN 113389)

The metal frame has corroded due to the salinity and odors in the south siphon transition structure. The corroding frame has contributed to the degradation of the concrete around the frame. The concrete structure has corroded to the extent that, during certain high tide events, water from the Sweetwater River can enter into the south SMI siphon transition structure. Figure 5 shows water entering the interior of the SMI siphon transition structure on July 7, 2020 at around 11:59 pm. On July 7, 2020, the high tide was at 6.25 feet around midnight (Table 3), which closely mirrors the conditions that would have occurred on April 10, 2020, the date and time of the SSO. A review of tidal information on April 10, 2020 (Table 4) indicates a height of 4.51 feet at 12:12 pm and 6.30 feet at 11:50 pm.

Consequently, it is possible that river water entered the south SMI siphon transition structure through the corroded concrete during the high tide event at 11:50 pm. The high tide event earlier in the day also likely allowed river water to enter the south SMI siphon transition structure if the stormwaters elevated the Sweetwater River elevation above the 5-foot elevation of the spillway.

- Repair the concrete around the duckbill valves to provide better support for the duckbill metal frame, and alleviate tidal flows from entering through this opening (City staff will be implementing in the near term)
- Engage the City's Engineering and Capital Projects Department to accelerate the improvements through the CIP process (ongoing)
- Perform an analysis with the City's primary vendor for odor and hydrogen sulfite control to evaluate the potential for mitigating the foul air at FSN 113189 (City staff will be implementing in the near term)

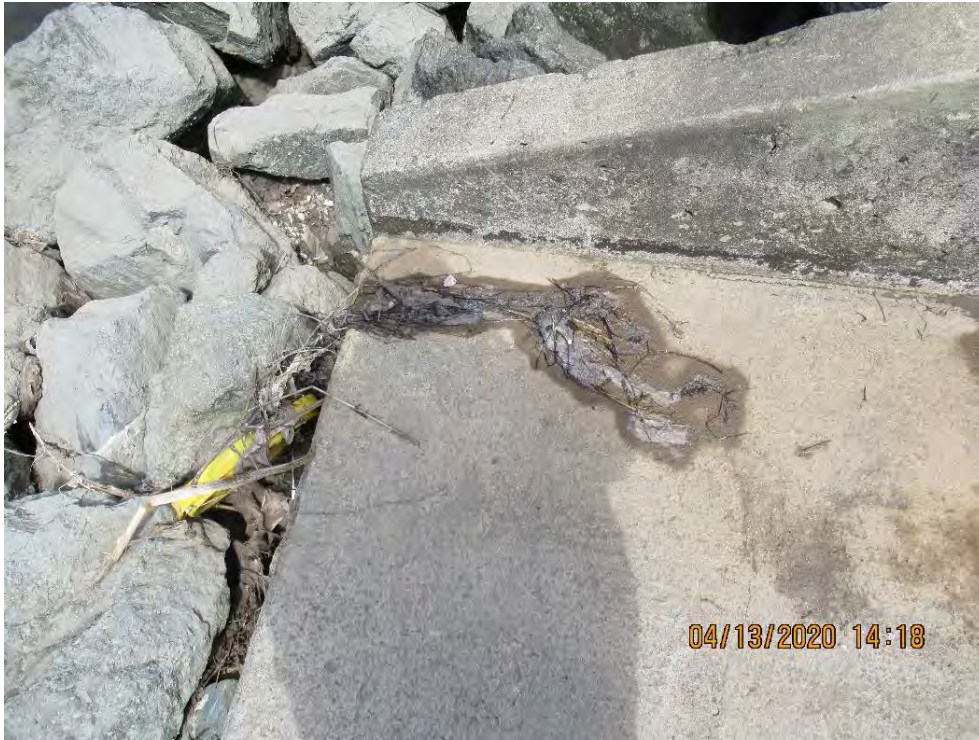
Photo 2. Debris at the End of the Southerly SMI Siphon Discharge Structure before Entering the Sweetwater River.

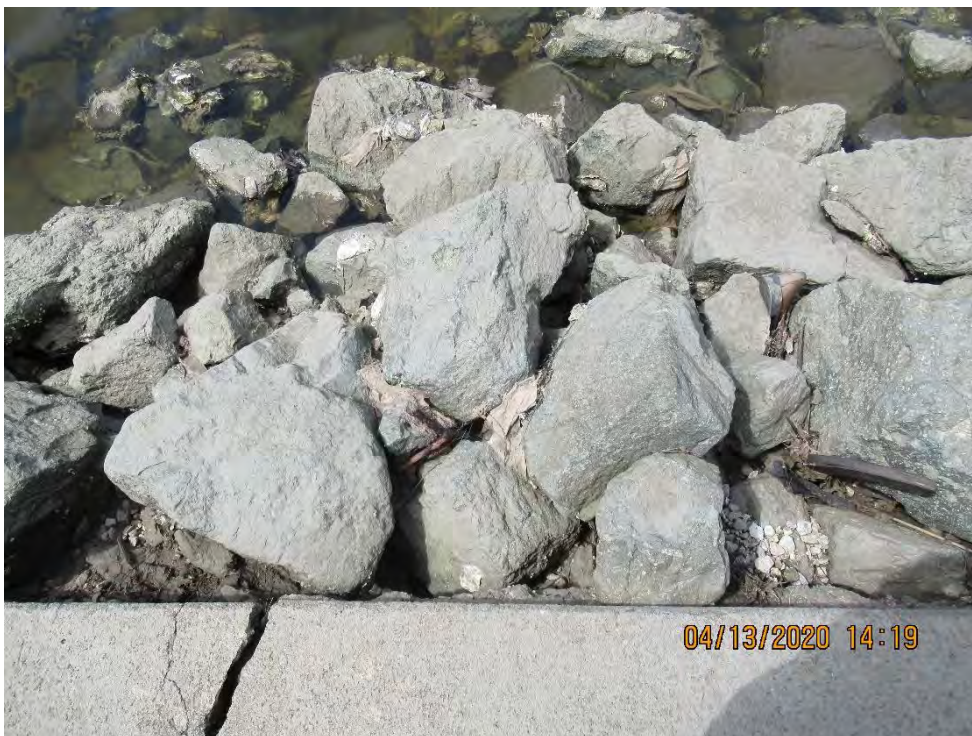
Photo 3. Debris at the End of the Southerly SMI Siphon Discharge Structure Looking toward the Sweetwater River

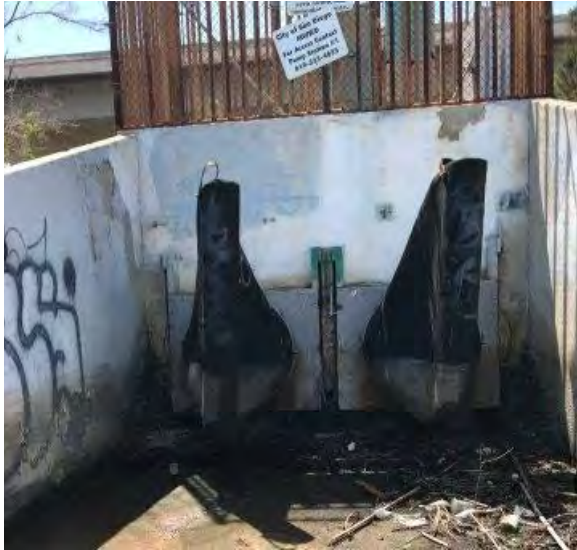
Figure 4. Spillway Duckbill Valves

The duckbill valves located at the south SMI siphon transition structure are designed properly and perform as designed. The duckbill valves replaced flapper gate valves, and they were installed on the existing flapper valve metal frame. The duckbill valves were assessed visually on May 11, 2020. The valves are in good condition with minimal wear.

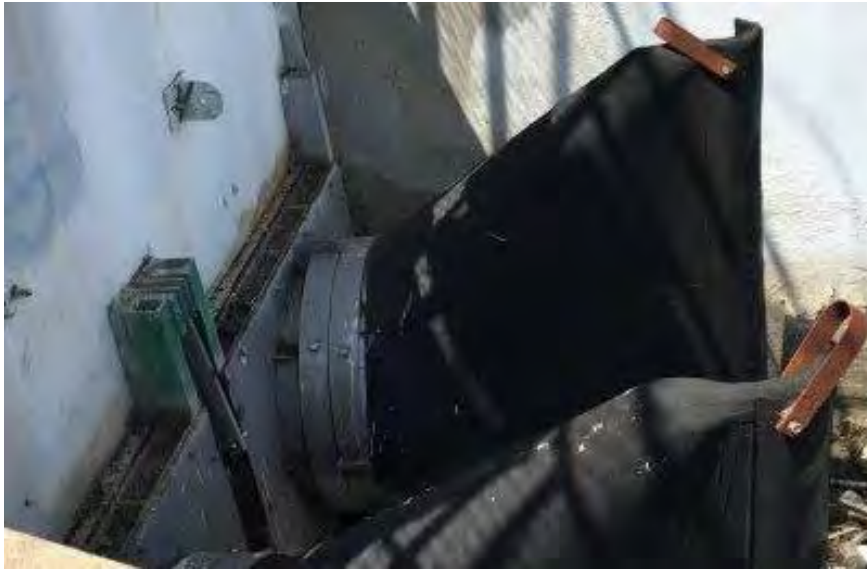
The new duckbill valves are mounted on a stainless steel plate. This plate is bolted to the frame of the flapper valves that have been since replaced (Figure 5).

Figure 5. Stainless Steel Plate Connection to Existing Frame

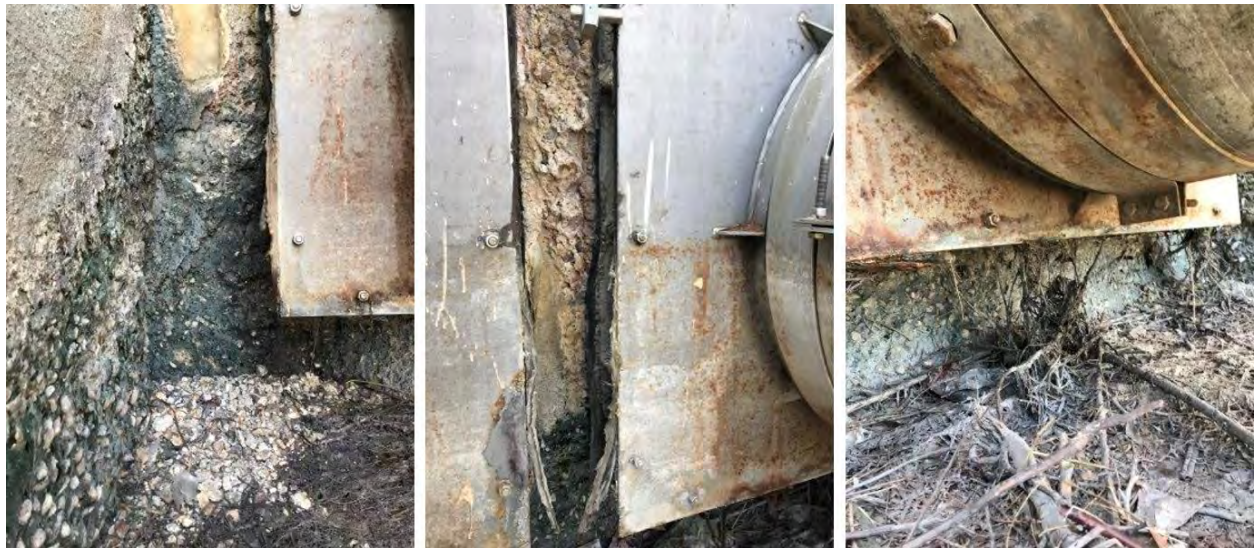
Figure 6. Duckbill Installation Plate Concrete Loss and Corrosion

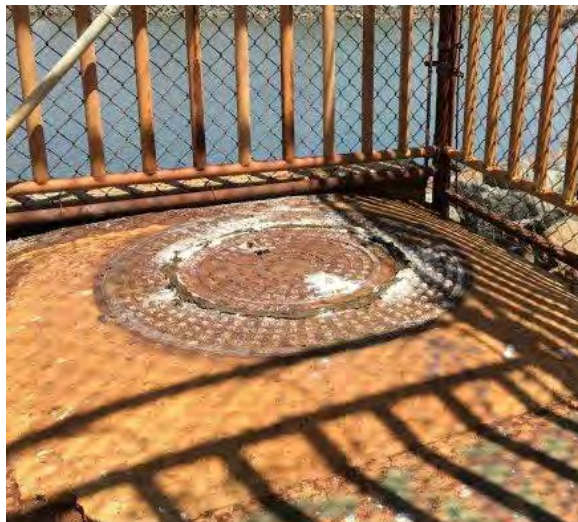
Figure 7 illustrates corrosion of the manhole cover, ring, handrails, and other metal structures on top. Figure 8 shows the site around the south transitional structure.

Figure 7. Corrosion of the South Transition Structure Manhole Cover

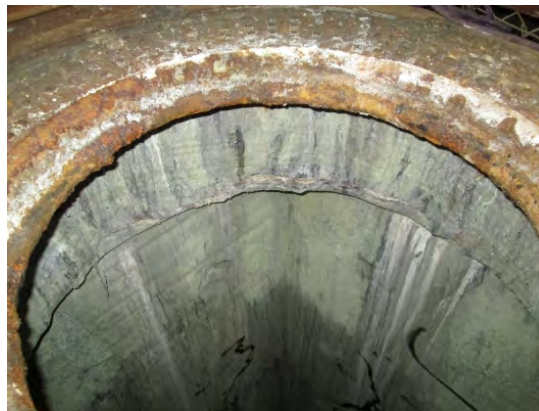
View of cuts in liner at bottom of short barrel section in manhole.

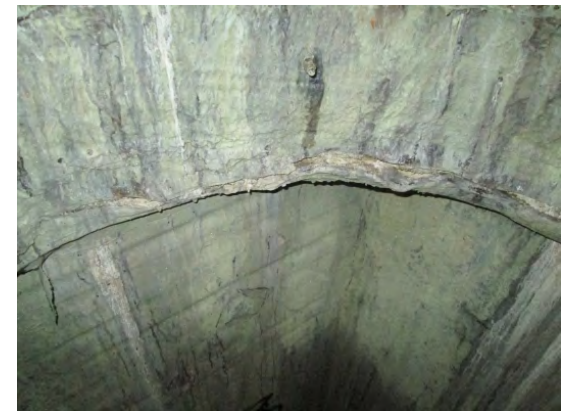
View of corroded manhole frame and cuts in liner at bottom of short barrel section in manhole.
