Special Meeting of the Metro Commission and Metro Wastewater JPA

- X 4. **ACTION:** CONSIDERATION AND POSSIBLE ACTION TO APPROVE THE MINUTES OF THE REGULAR MEETING OF [October 1, 2020](#) (**Attachments**)
- X 5. **PRESENTATION:** SUMMARY OF APRIL 10, 2020 CITY OF SAN DIEGO SANITARY SEWER OVERFLOW INCIDENT (Tom Rosales/Dean Gipson HDR) (**Attachment**)

Subject: Notice of Violation No. R9-2020-0204 and Investigative Order No. R9-2020-0205 for the Reported April 10, 2020 Unauthorized Discharge to Sweetwater River - Written Responses

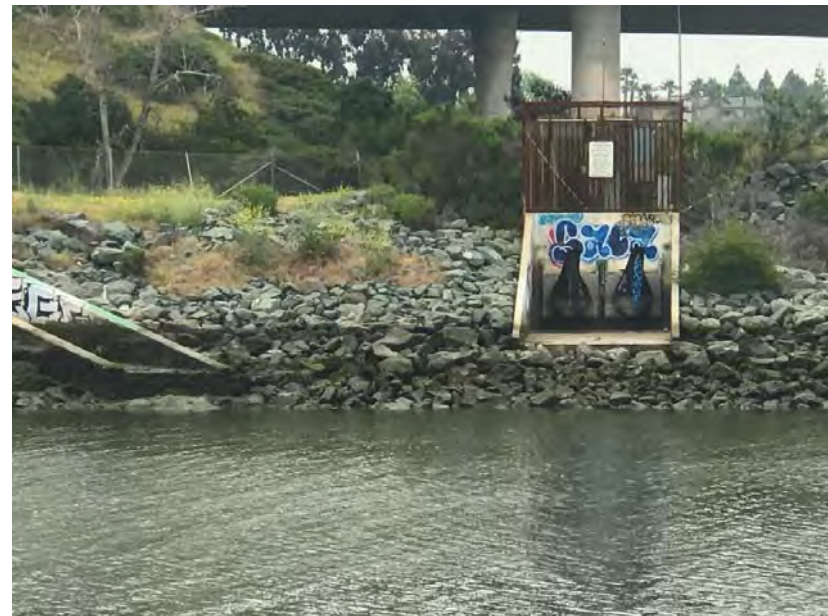
South Siphon Transition Structure

- Replace level sensor in the south siphon transition structure with an upgraded redundant level indicator with cellular communication
- Repair concrete around duckbill valves to stop inflow at high tides
- Complete cleaning of all siphons
- Establish cleaning frequency of all siphons
- Review and update O&M procedures for wastewater pump stations

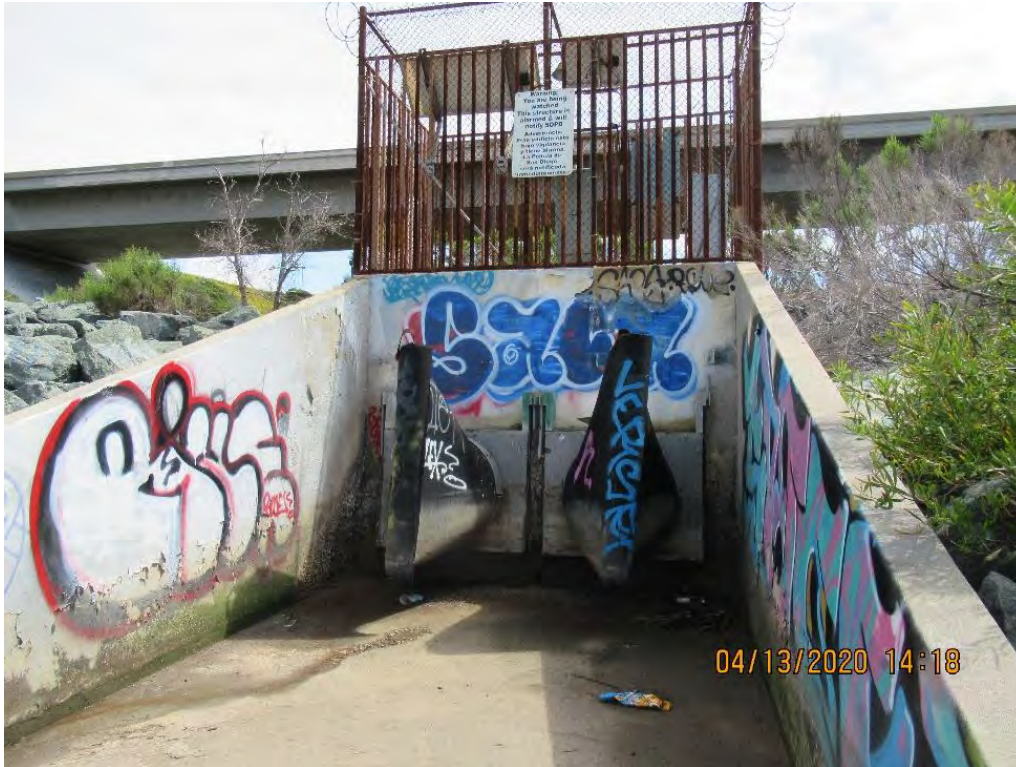
Photo 1. SMI Siphon Transition Structure on the South Bank of the Sweetwater River

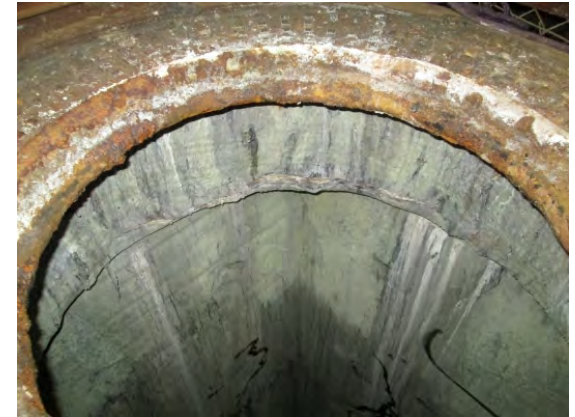
Location: Riser

Severity: Moderate

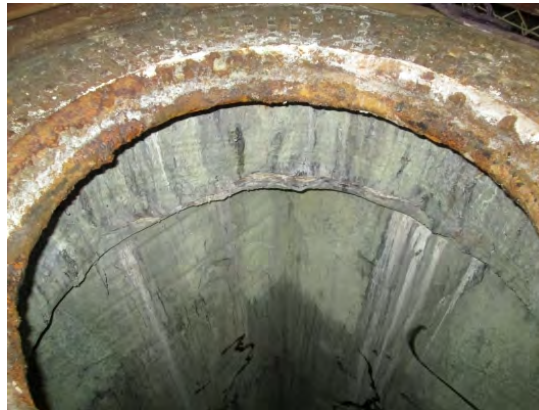
View of cuts in liner at bottom of short barrel section in manhole.

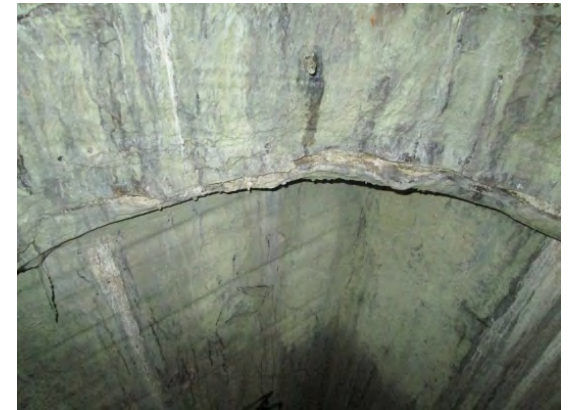
View of corroded manhole frame and cuts in liner at bottom of short barrel section in manhole.
