METRO TAC AGENDA
(Technical Advisory Committee to Metro JPA)

3. **REPORT:** Update from Residuals Management Working Group (Padre Dam MWD)
 4. **PRESENTATION:** Summary of April 10, 2020 City of San Diego Sanitary Sewer Overflow Incident (Tom Rosales/Dean Gipson HDR) (**Attachment**)

Subject: Notice of Violation No. R9-2020-0204 and Investigative Order No. R9-2020-0205 for the Reported April 10, 2020 Unauthorized Discharge to Sweetwater River - Written Responses

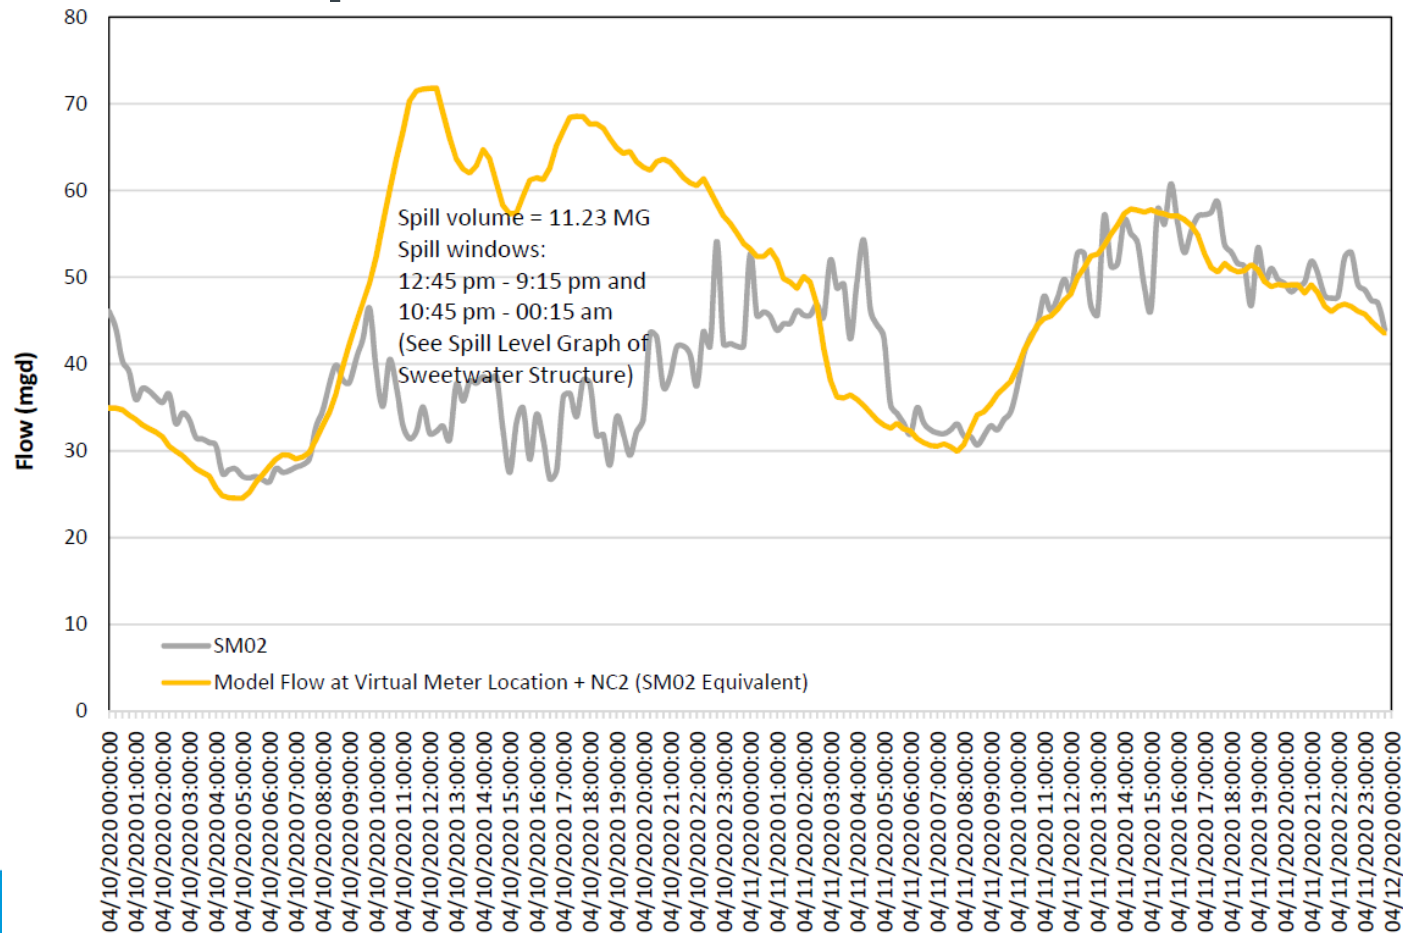
SM02 and Total Upstream Meter Volumes

- flow from 17 tier-one meters was evaluated along the SMI that make up the total flow to PS1
- Subtracted volumes from the meter downstream of the overflow structure from the flow summation of all meters upstream of the overflow structure
- InfoWorks dynamic modeling software used to simulate the total flow of upstream meters

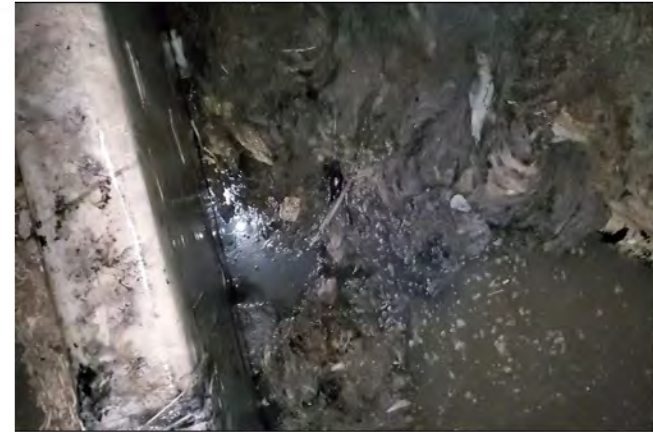
Rags/debris in Barrel 2

- Completed investigation and submitted SSO Technical Report June 17, 2020
- Removed blockage in Siphon Barrel #2 by July 15, 2020
- Cleaned debris from all 4 barrels at Sweetwater River by September 19, 2020
- Initiated programmatic inspection & cleaning of all siphons not yet on a routine cleaning program (12 locations)

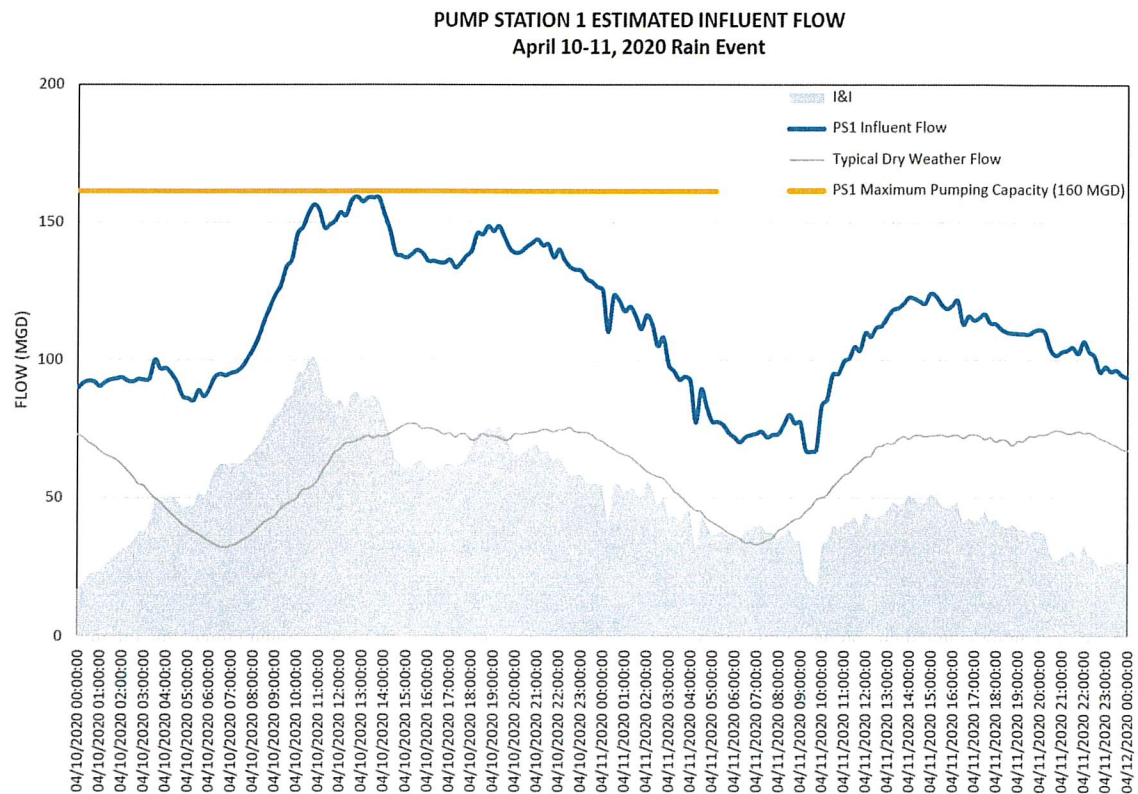
Figure 2. PS1 Influent Flow on April 10-11, 2020

flow. Based on the data, PS1 had a peak of about 158 MGD (Figure 2) that occurred on April 10, 2020. PS1 is designed to pump a maximum capacity of 160 MGD, which is sufficient volume to convey the flows experienced in the system on April 10, 2020.

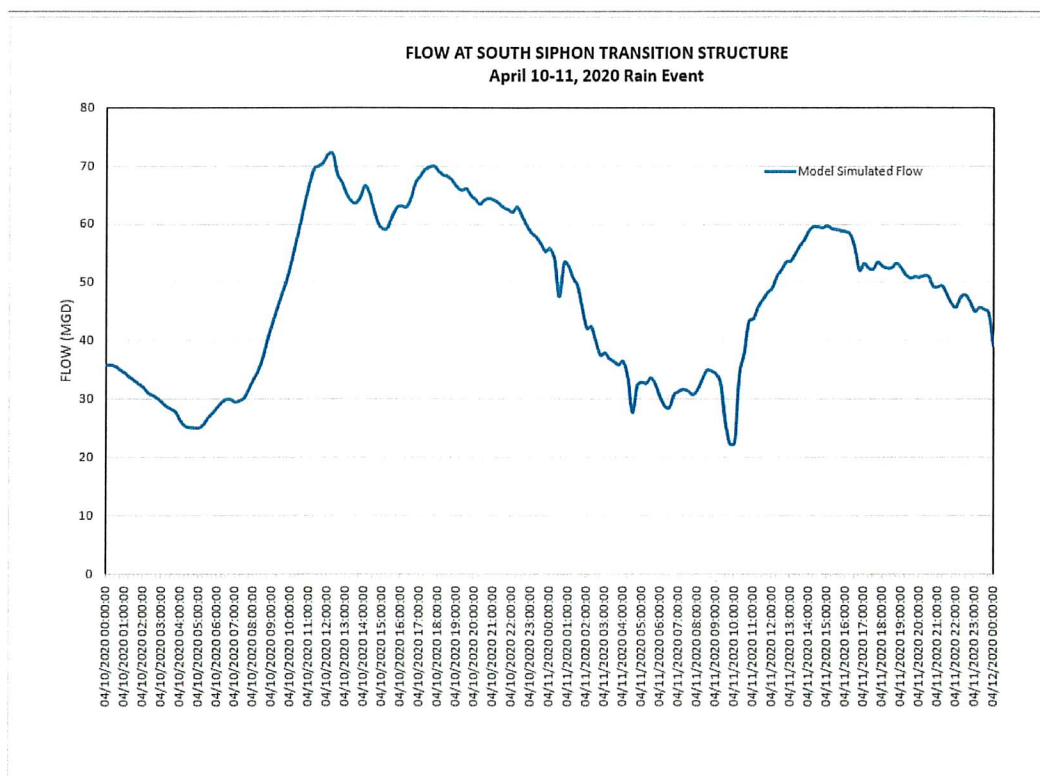
Figure 3. Flows at South Siphon Transition Structure (estimated)

In a similar manner, the peak wet weather flow at the south siphon transition structure was estimated to be approximately 73 MGD (Figure 3). The siphon system has a capacity of approximately 105 MGD. Therefore, based on the maximum pumping capacity of PS1 and the system storage available in the siphons an SSO would not have occurred.

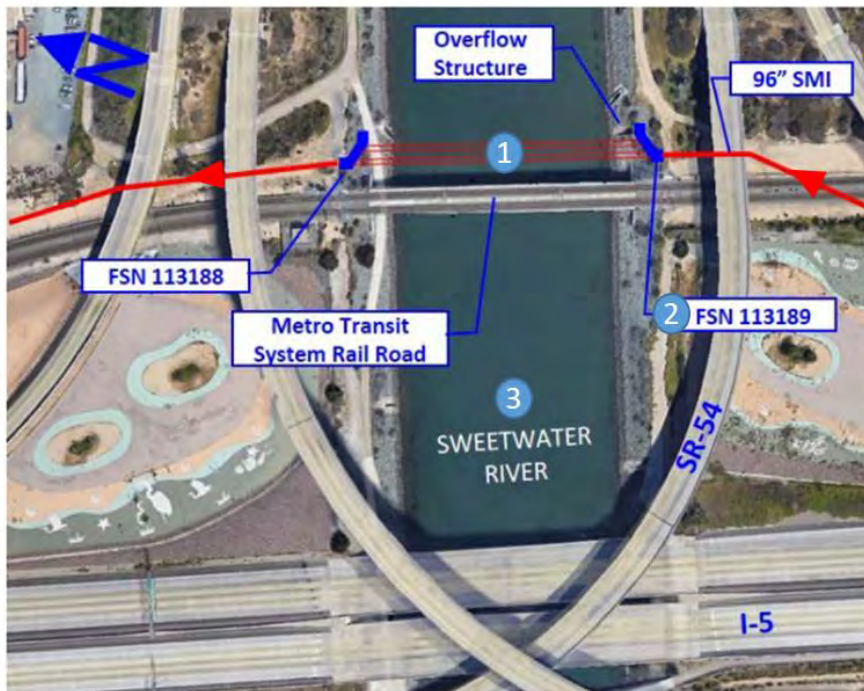
Figure 1. Location Map

Figure 1 shows the siphon, which directs wastewater flows from the SMI across the Sweetwater River, and which was constructed in 1971 to replace a 90-inch-diameter reinforced concrete pipe (RCP) sewer. The siphon consists of two transition structures, one on the south river bank (FSN 113189) and the other on the north river bank (FSN 113188) of the Sweetwater River and four elliptical barrels, each approximately 415 feet long, encased in concrete. The south transition structure is designed with two 48-inch duckbill valves that, when flow and surge exceeds the drawdown capacity of the downstream pump station (PS1), wastewater flow will discharge through the duckbill valves. Because of the elevation of the south transition structure, it can at times be submerged by tidal flows in the San Diego Bay. The duckbill valves are designed to not allow inflow into the system during high tide events. But as seen in Figure 6 of the HDR Technical Memorandum (dated 5/11/18 and included in Attachment 10), the aluminum frame embedded in the concrete around the duckbill valves, is severely corroded, and can allow tidal flows into the structure under certain circumstances.

- Marker #1: Based on post-SSO investigation and hydraulic modeling analysis, the City has determined that a large ragball partially blocked flow in Siphon 2 and debris accumulation in Siphon 3 reduced capacity of the siphons and contributed to the SSO.

- Marker #2: The location of the SSO appearance point is at the siphon transition structure (FSN 113189) on the south bank of the Sweetwater River, near the address 401 West 35th Street, National City, California 91950. The wastewater likely entered the Sweetwater River by exiting the siphon's south transition structure, then flowed westerly toward and into San Diego Bay. City crews investigating the area upon notification of a spill found minimal visual evidence of a spill at the south transition structure (Photo 1 through Photo 3 on pages 10 and 11). The lack of more physical evidence of an overflow is likely due to the tidal influences of the Sweetwater River that would have washed away visible evidence. Hydraulic modeling efforts identify a single point of spill, which is most likely the low point at the southerly siphon transition structure.

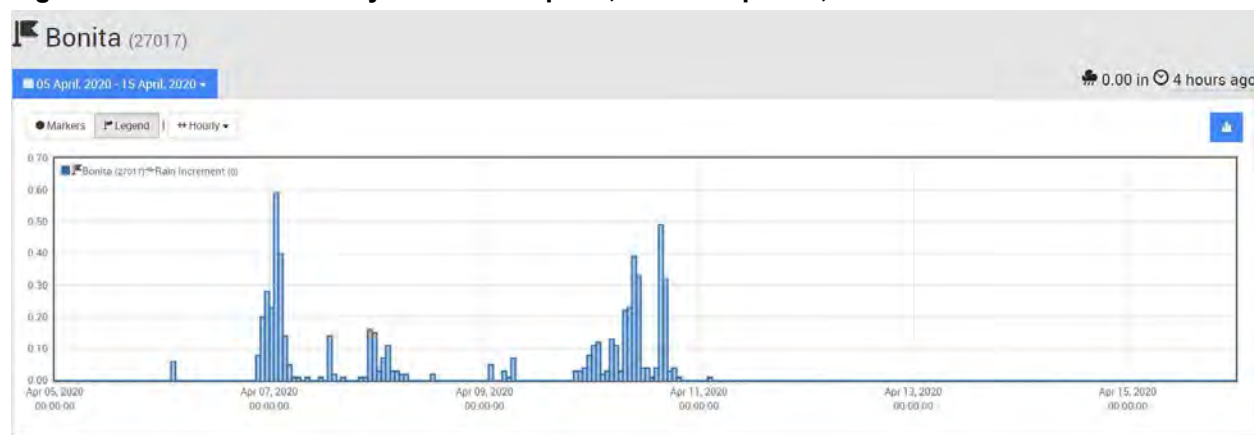
Figure 2. Rainfall Volumes by Hour from April 5, 2020 to April 15, 2020

- Significant rainfall events:** From late at night on April 6, 2020 to the early morning of April 7, 2020, and again late at night on April 9, 2020 to the evening of April 10, 2020, significant amounts of rain inundated the San Diego area. The first rain event likely saturated the ground throughout San Diego County, creating conditions for immediately subsequent rain events to increase the groundwater runoff and water table levels. The intensity of similar rain events have historically caused infiltration and inflow into the wastewater collection system in volumes that increase flows within the systems. Based on the rainfall intensity patterns in the area closest to the transition structure, as shown in Figure 2, it is reasonable to assume that some of the April 10, 2020 storm runoff would have entered the wastewater collection system and contributed to the overflow.

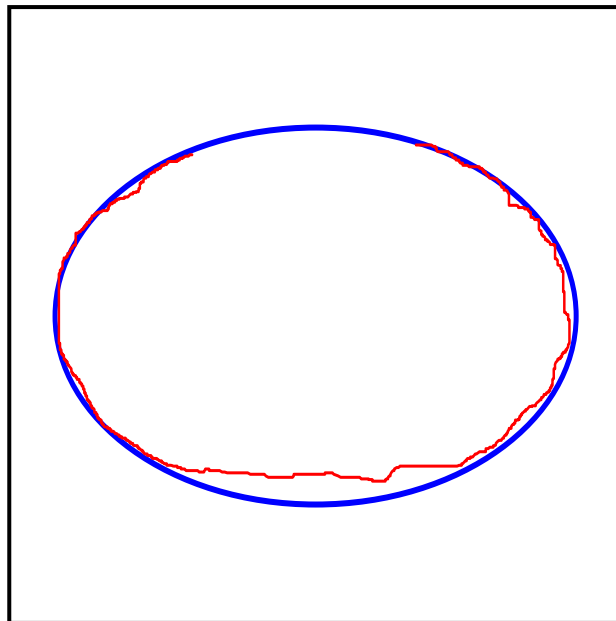
Counter: 0.0 Ft
Code Description: Start of Survey
Remarks: J28S-13_WL-95_Sonar Scan 1157
Maximum X Restriction 5.61 %
Depth of Debris ft

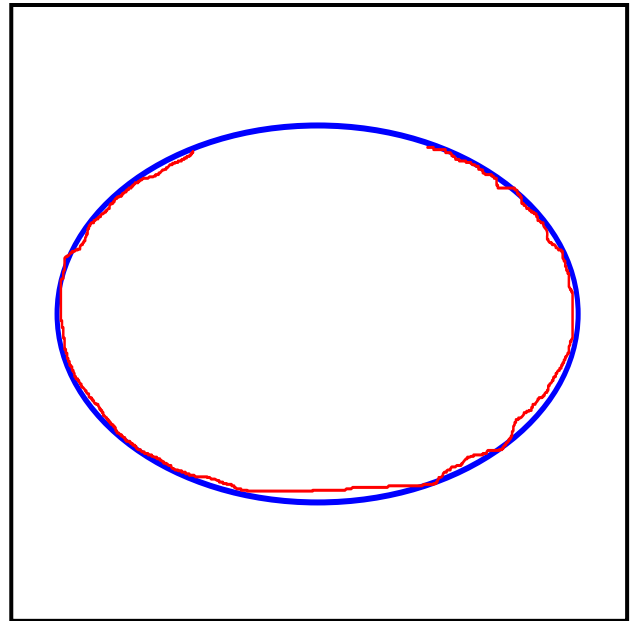
Counter: 100.0 Ft
Code Description: General observation
Remarks: Sonar Scan 1205
Maximum X Restriction 3.21 %
Depth of Debris 0.115 ft

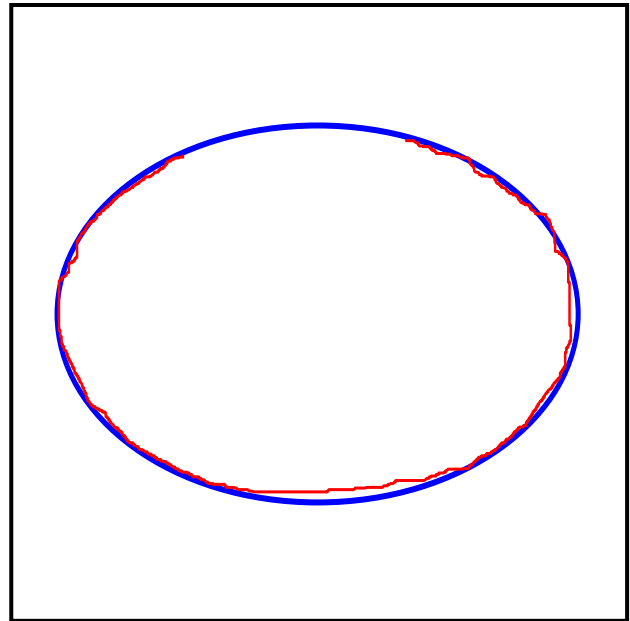
Counter: 141.2 Ft
Code Description: General observation
Remarks: Sonar Scan 1208
Maximum X Restriction 3.21 %
Depth of Debris 0.115 ft

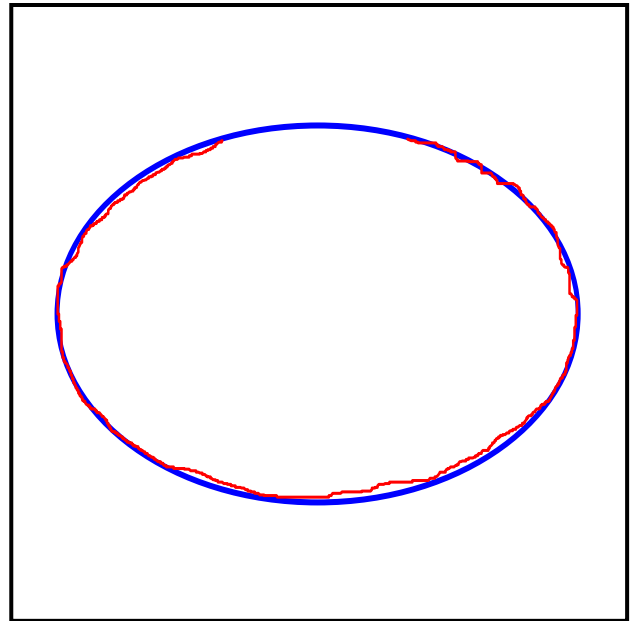
Counter: 180.5 Ft
Code Description: General observation
Remarks: Sonar Scan 1210
Maximum X Restriction 2.14 %
Depth of Debris 0.0766 ft

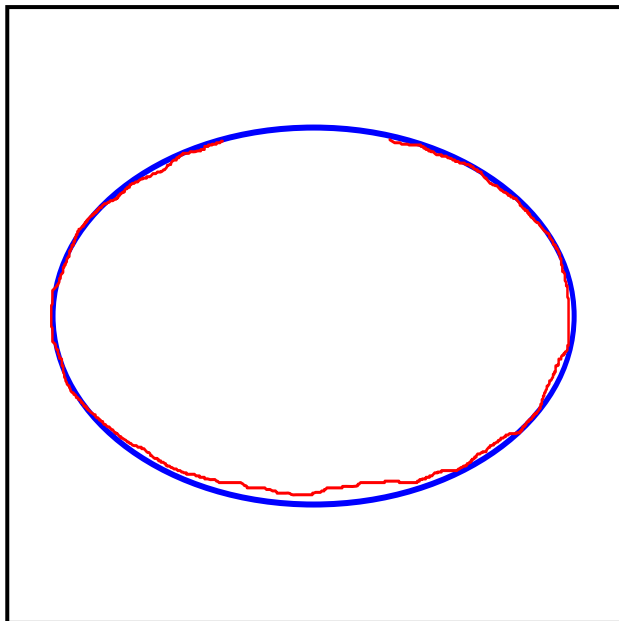
Counter: 0.0 Ft
Code Description: Start of Survey
Remarks: J28S-13_WL 95
Maximum X Restriction 4.01 %
Depth of Debris 0.1437 ft

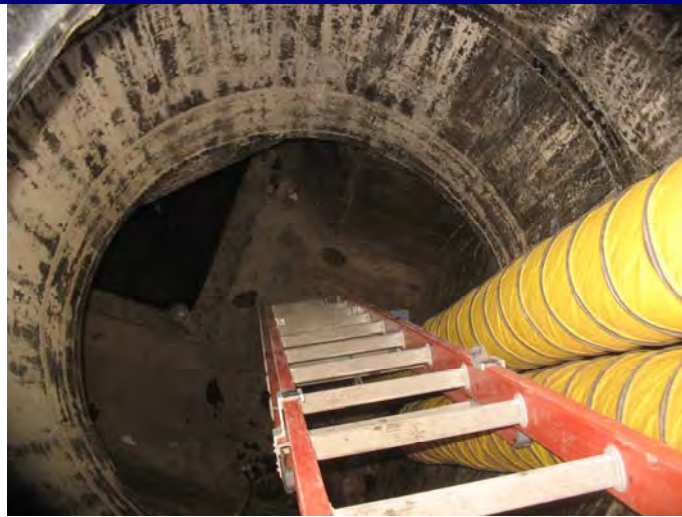
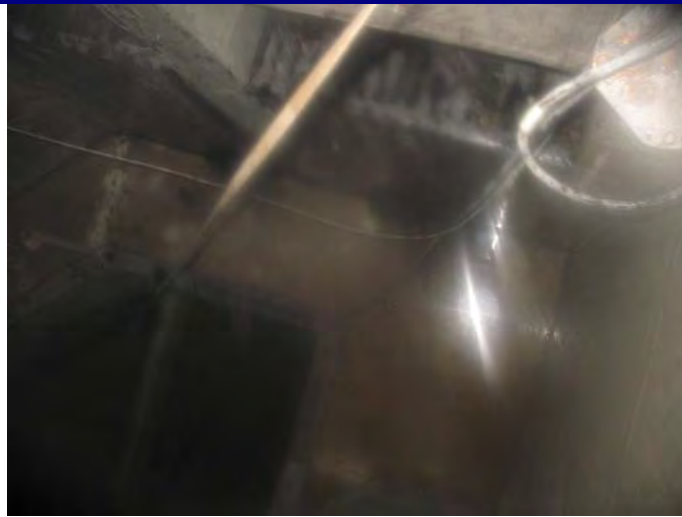
M3 - Down Manhole

TASK AREA #:	Siphon	INSPECTION Firm:	Downstream	MH FSN:	113189
INSPECTION DATE:	10/15/2009	INSPECTION TIME:	10:36	Field Book Page / Map ID#	J28S13
Dispatch:	Maintenance	INSPECTION Crew:	DR/HH	Street:	RoW, Sweetwater River
Dispatch Comments:	large vault, headworks of siphon; lightly corroded T-lock liner; siphon cleaning in progress: ventilator set up at insp.

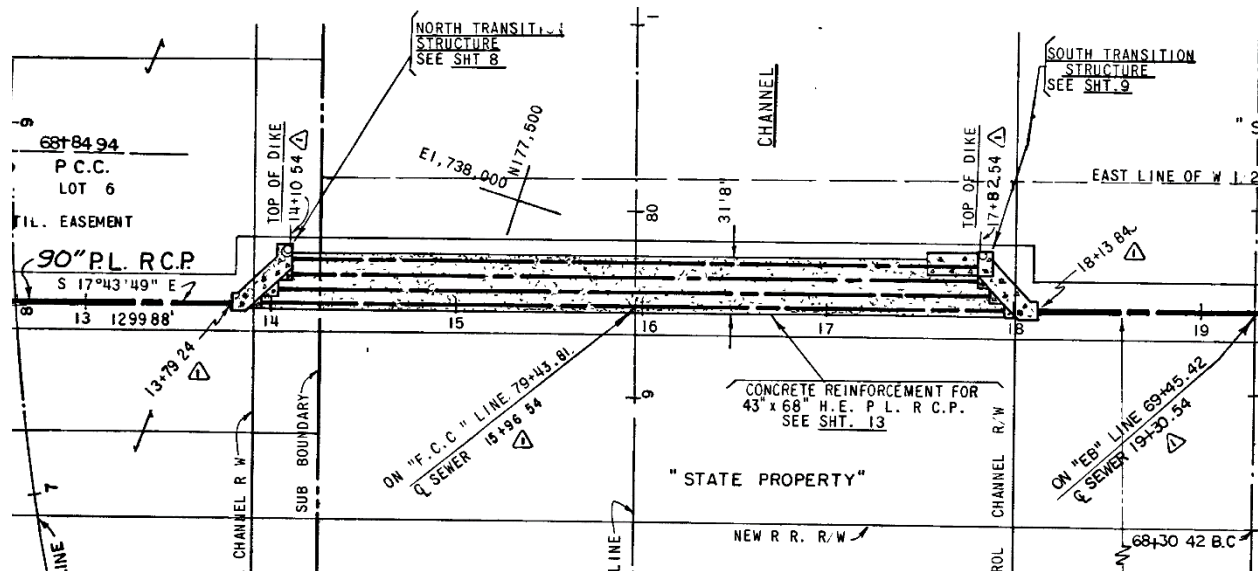
Figure 1. Sweetwater River Crossing Siphon

The siphon, which allows the South Metropolitan Interceptor (SMI) to cross the Sweetwater River, was constructed in 1971 to replace a 90-inch-diameter reinforced concrete pipe sewer. The siphon consists of two transition structures: one on the south river bank (Facility Sequence Number [FSN] 113189) and the other on the north (FSN 113188) river bank, as well as four elliptical barrels encased in concrete (Figure 1). The siphon location is shown in Figure 2.

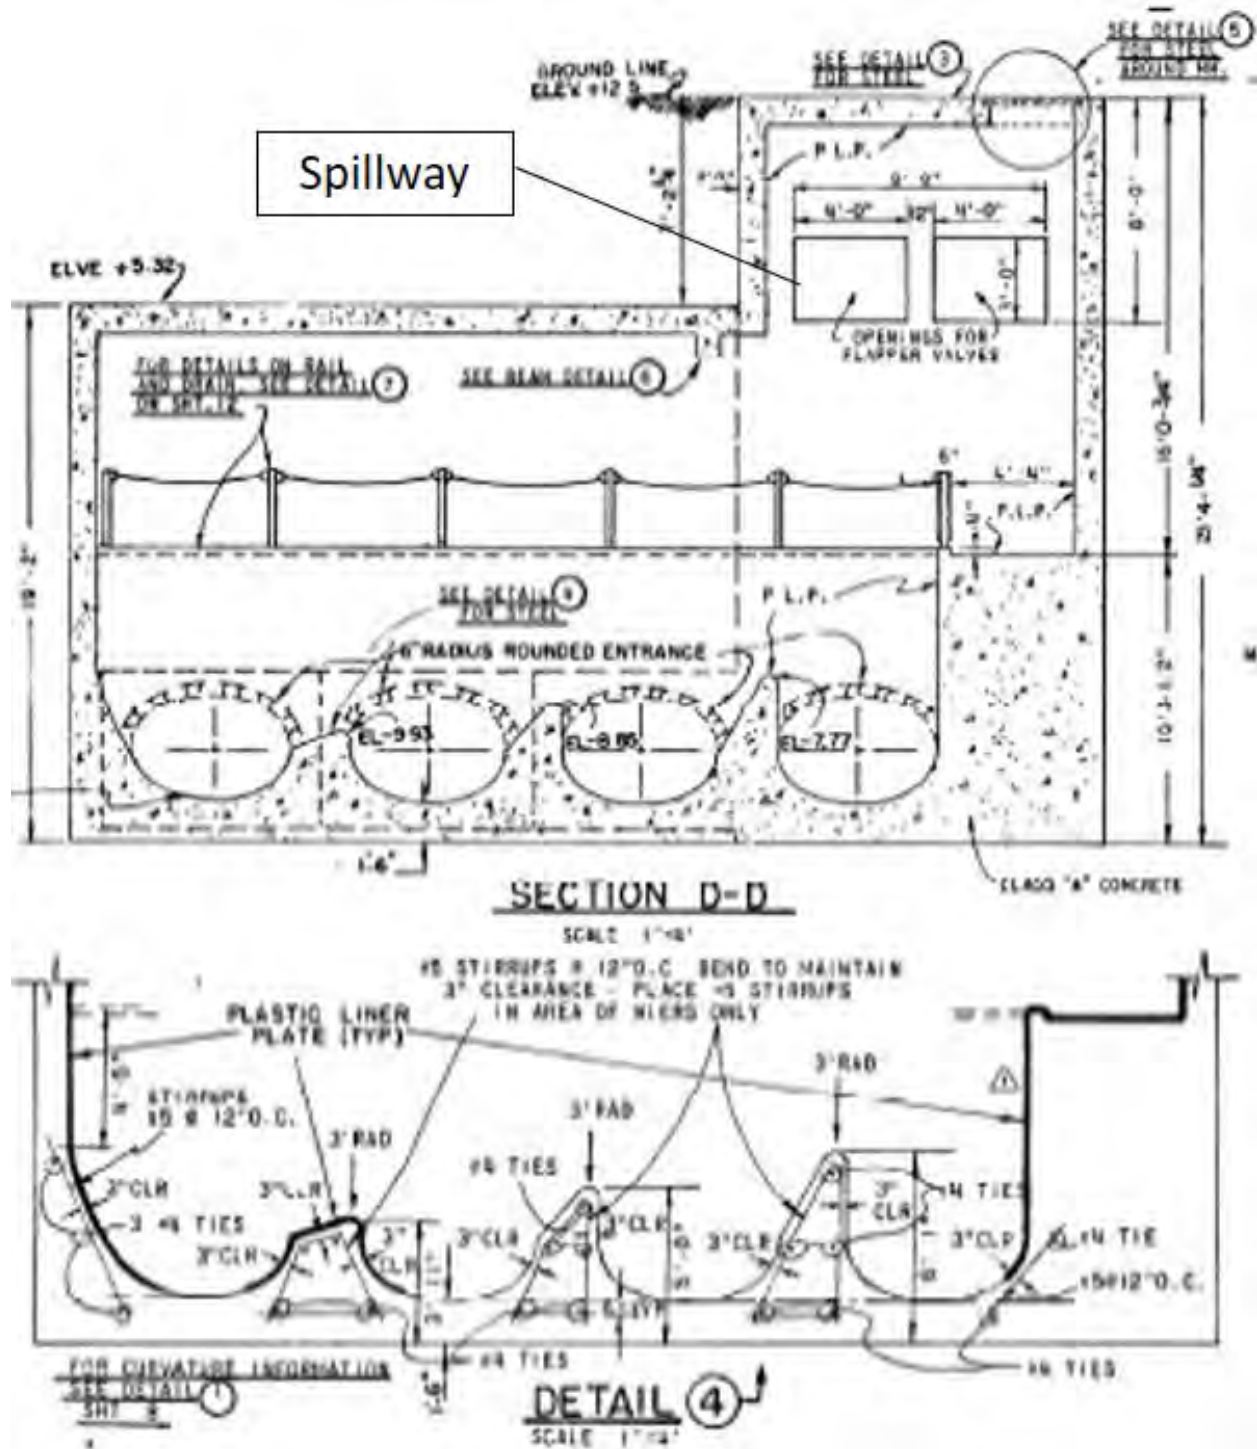
Figure 3. Sweetwater River Crossing Siphon

FSN 113189 receives wastewater flow through the 90-inch-diameter SMI reinforced concrete pipe and the 54-inch-diameter reinforced concrete pipe Sweetwater sewer pipe. The bottom channel includes ridges that facilitate distribution of the flow into the siphon barrels (Figure 3).

The siphon shaft is fitted with two square openings (Figure 3). These openings are overflow structures to be used in an emergency, allowing wastewater to overflow should Pump Station 1 fail. The overflow structures were originally fitted with flapper valves. The City of San Diego replaced these with duckbill valves at a later date. Figure 4 shows the FSN 113189 duckbill valves.

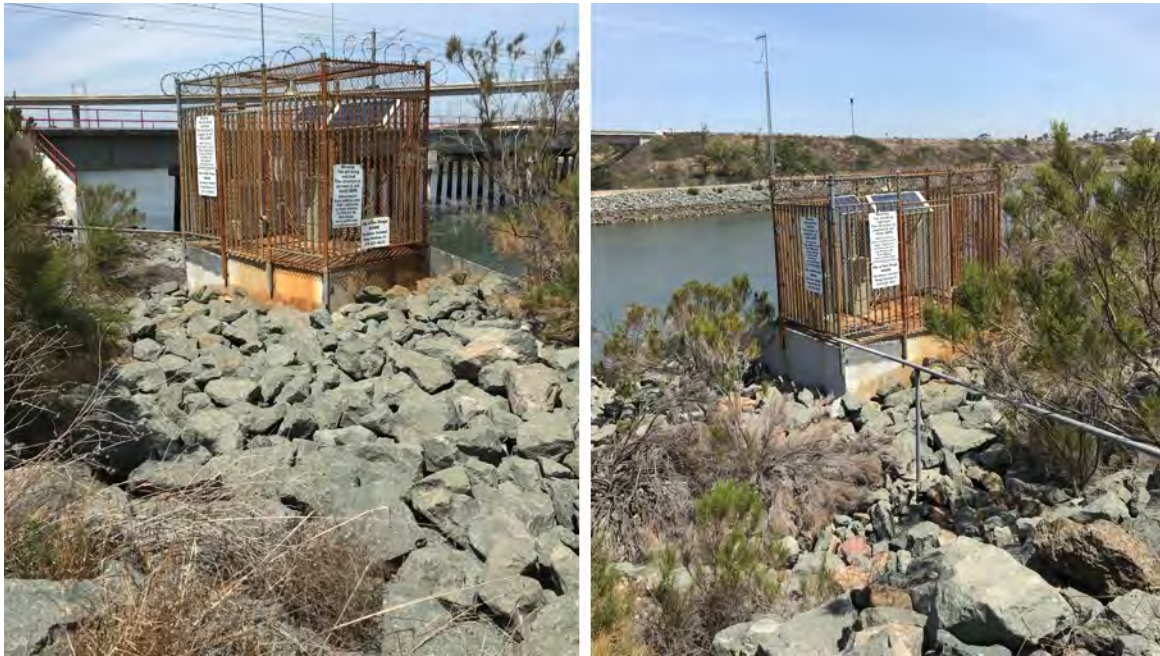
Figure 8. Site around the South Transitional Structure

Figure 7 illustrates corrosion of the manhole cover, ring, handrails, and other metal structures on top. Figure 8 shows the site around the south transitional structure.

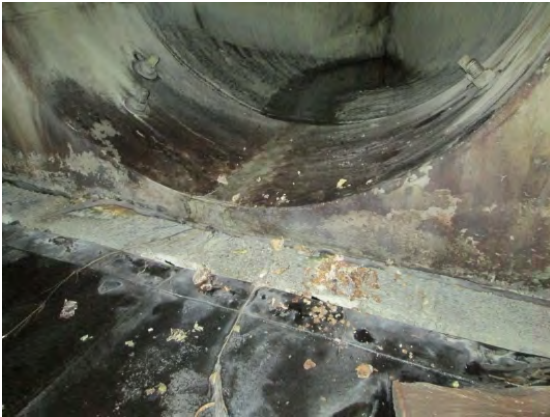
The majority of the vertical walls and top horizontal portion of each overflow box, where the liner terminates has delaminated from the underlying concrete and has allowed the concrete to be deteriorated.

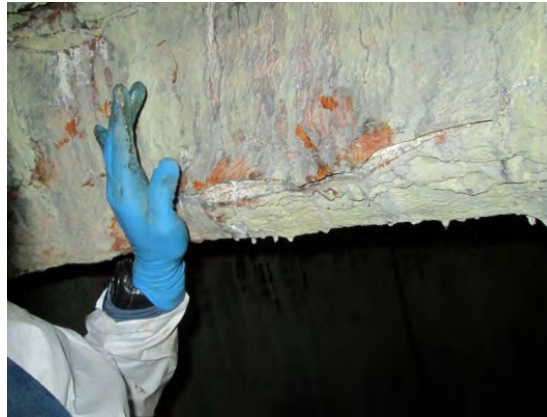
Location: Overflow Channel

Severity: Moderate

Approximately 75% of the circumference has splits/tears in liner. The concrete underneath is soft.

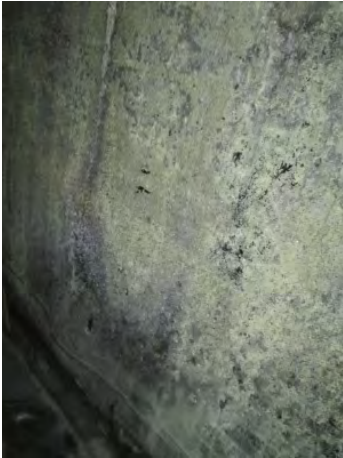
Blisters were noted in the liner on the wall of the main structure.

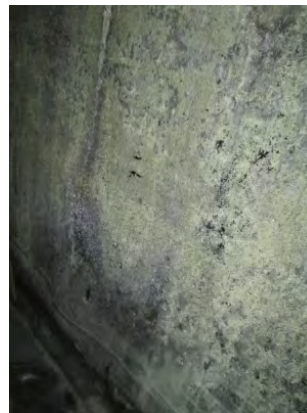
View of seam and bubbles on vertical wall in main structure.

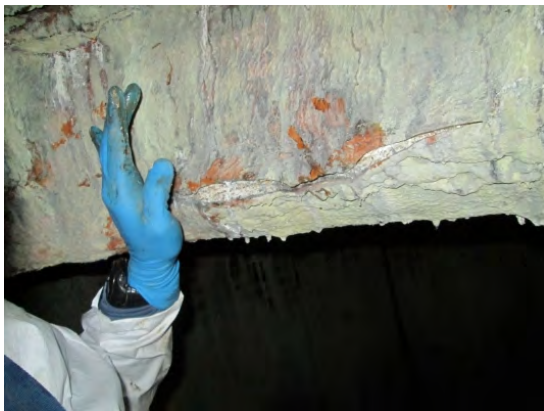
View of cuts in liner at bottom of short barrel section in manhole.
