Special Meeting of the Metro Commission and Metro Wastewater JPA

- X 4. **ACTION:** CONSIDERATION AND POSSIBLE ACTION TO APPROVE THE MINUTES OF THE REGULAR MEETING OF [October 1, 2020](#) (**Attachments**)
- X 5. **PRESENTATION:** SUMMARY OF APRIL 10, 2020 CITY OF SAN DIEGO SANITARY SEWER OVERFLOW INCIDENT (Tom Rosales/Dean Gipson HDR) (**Attachment**)

Subject: Notice of Violation No. R9-2020-0204 and Investigative Order No. R9-2020-0205 for the Reported April 10, 2020 Unauthorized Discharge to Sweetwater River - Written Responses

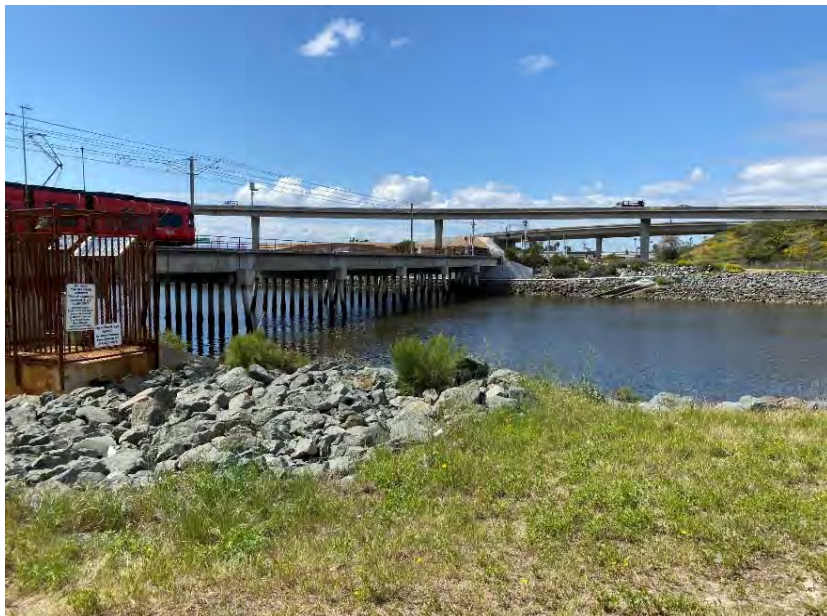
South Metro Interceptor South Siphon Transition Structure

Looking north across Sweetwater River

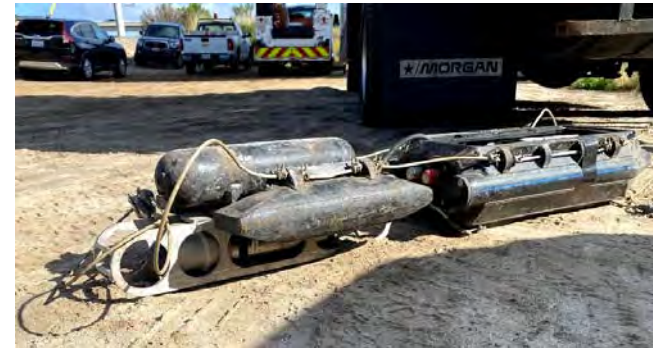
Sonar on skid

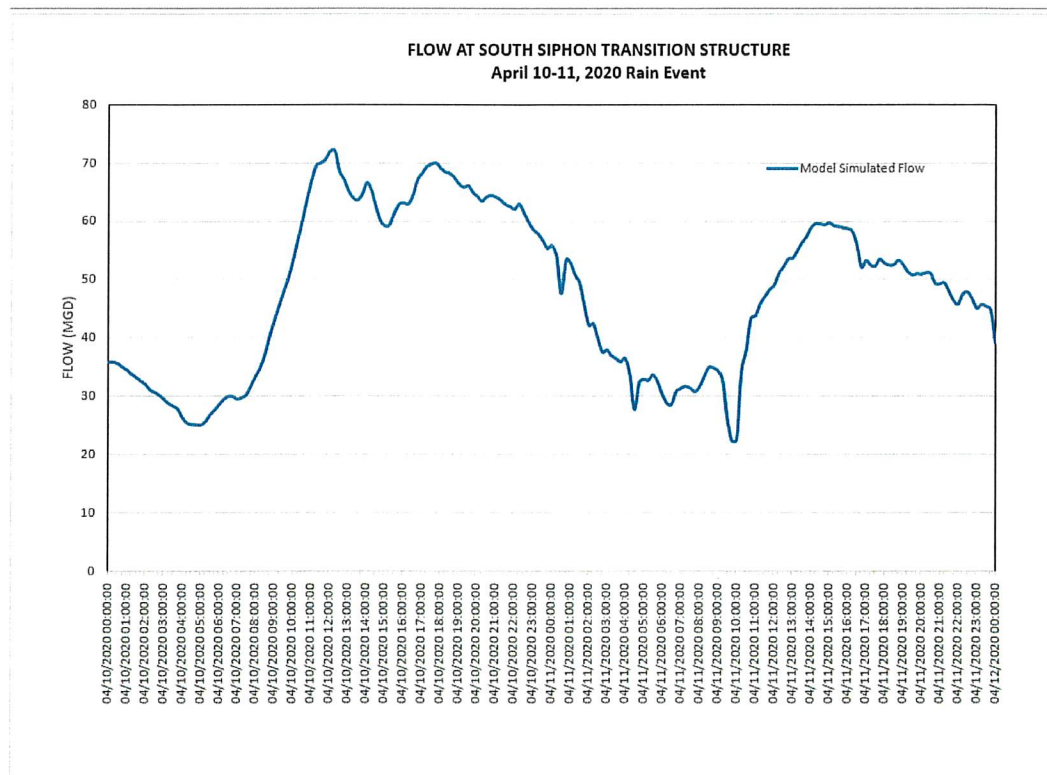
Figure 3. Flows at South Siphon Transition Structure (estimated)

In a similar manner, the peak wet weather flow at the south siphon transition structure was estimated to be approximately 73 MGD (Figure 3). The siphon system has a capacity of approximately 105 MGD. Therefore, based on the maximum pumping capacity of PS1 and the system storage available in the siphons an SSO would not have occurred.

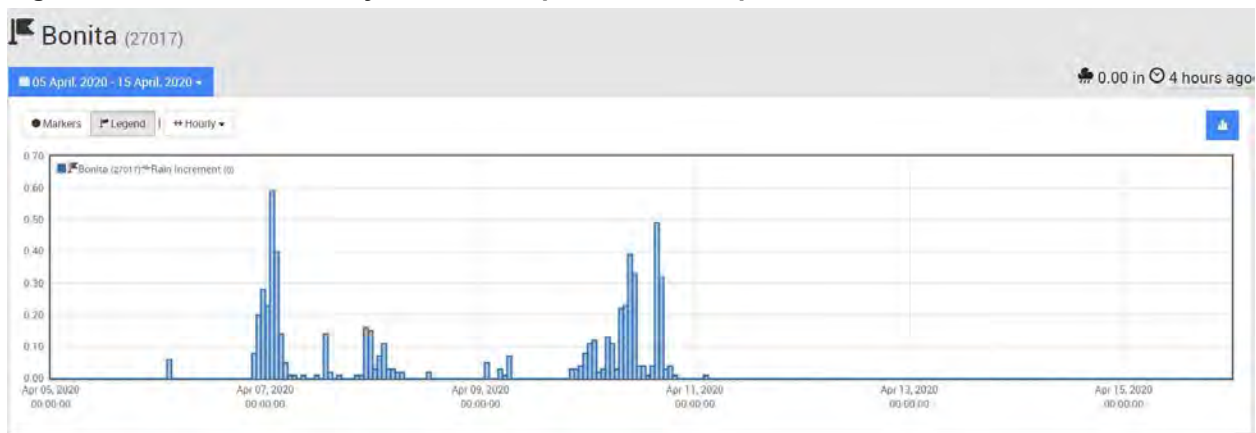
Figure 2. Rainfall Volumes by Hour from April 5, 2020 to April 15, 2020

- **Significant rainfall events:** From late at night on April 6, 2020 to the early morning of April 7, 2020, and again late at night on April 9, 2020 to the evening of April 10, 2020, significant amounts of rain inundated the San Diego area. The first rain event likely saturated the ground throughout San Diego County, creating conditions for immediately subsequent rain events to increase the groundwater runoff and water table levels. The intensity of similar rain events have historically caused infiltration and inflow into the wastewater collection system in volumes that increase flows within the systems. Based on the rainfall intensity patterns in the area closest to the transition structure, as shown in Figure 2, it is reasonable to assume that some of the April 10, 2020 storm runoff would have entered the wastewater collection system and contributed to the overflow.

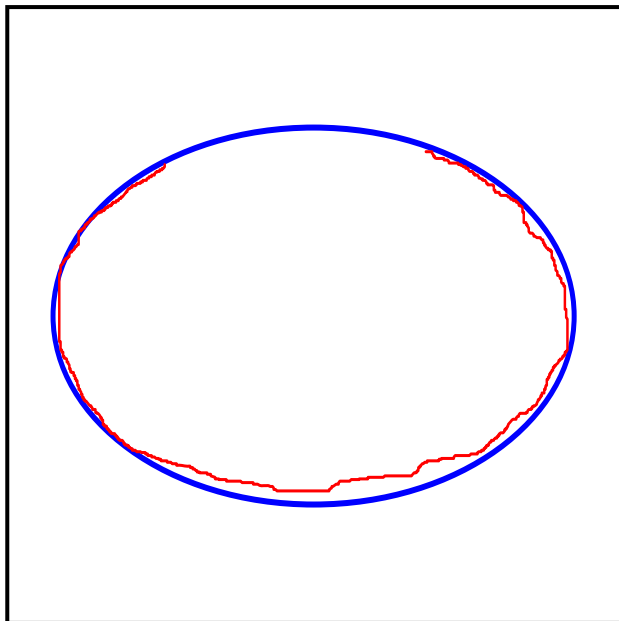
Counter: 0.0 Ft
Code Description: Start of Survey
Remarks: J28S-13_WL-95_Sonar Scan 1157
Maximum X Restriction 5.61 %
Depth of Debris ft

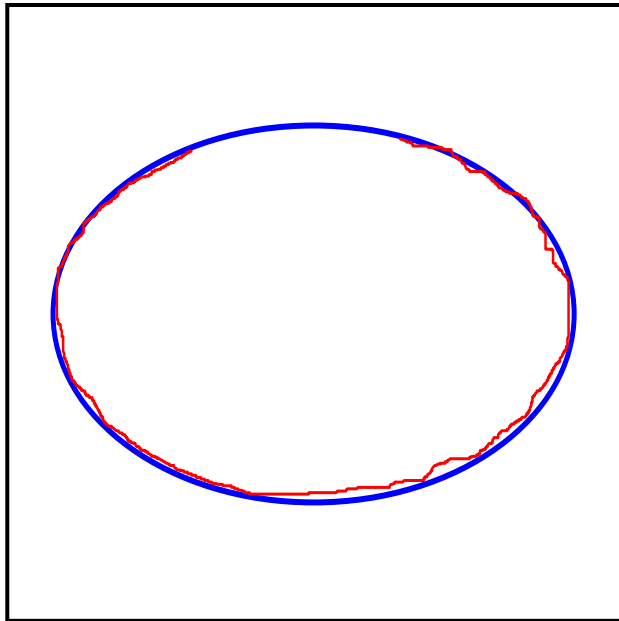
Counter: 42.7 Ft
Code Description: General observation
Remarks: Sonar Scan 1201
Maximum X Restriction 2.41 %
Depth of Debris 0.0862 ft

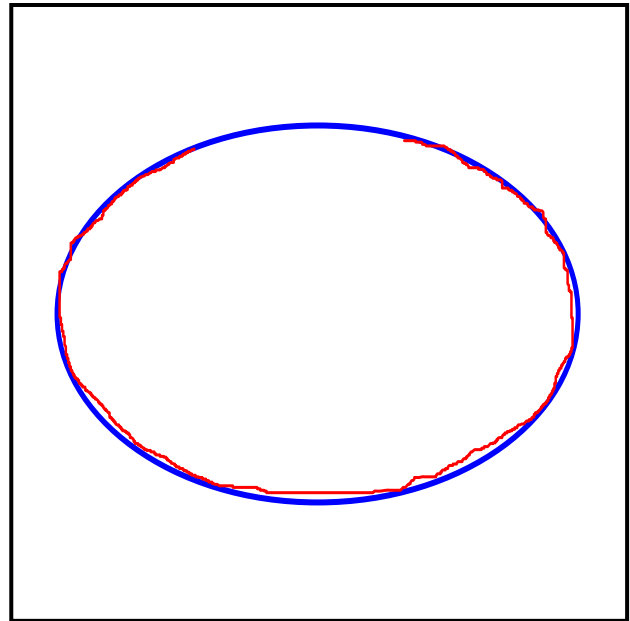
Counter: 60.0 Ft
Code Description: General observation
Remarks: Sonar Scan 1203
Maximum X Restriction 2.41 %
Depth of Debris 0.0862 ft

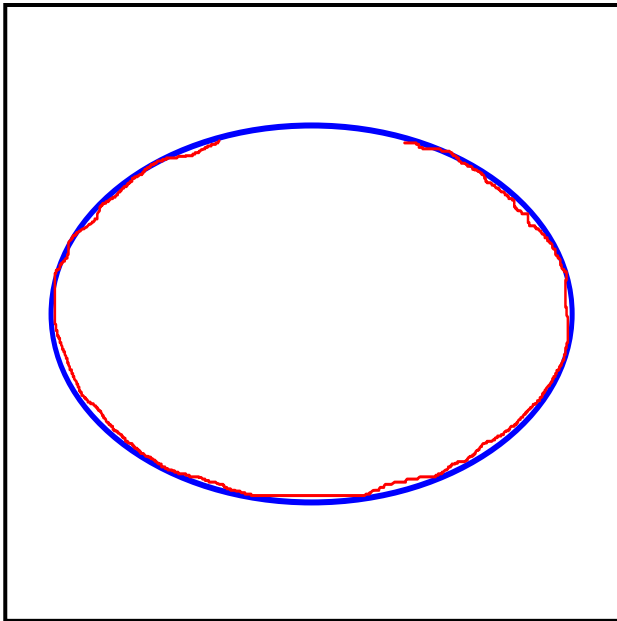
Counter: 122.4 Ft
Code Description: General observation
Remarks: Sonar Scan 1206
Maximum X Restriction 1.6 %
Depth of Debris 0.0575 ft

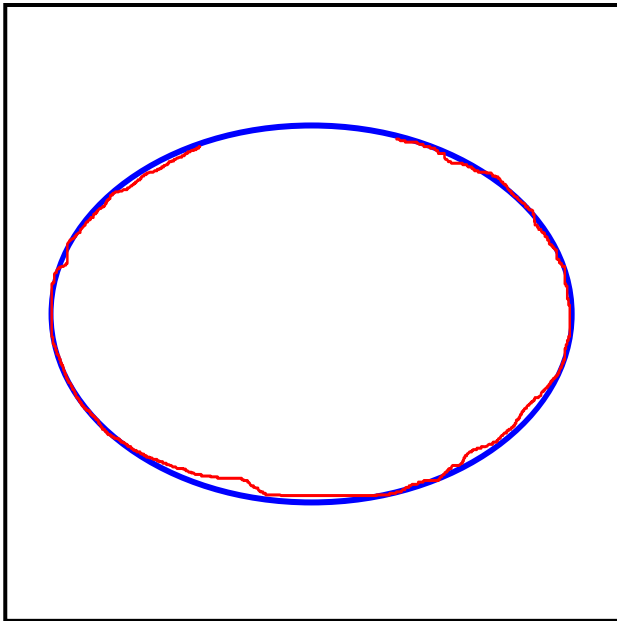
Counter: 160.2 Ft
Code Description: General observation
Remarks: Sonar Scan 1209
Maximum X Restriction 2.14 %
Depth of Debris 0.0766 ft

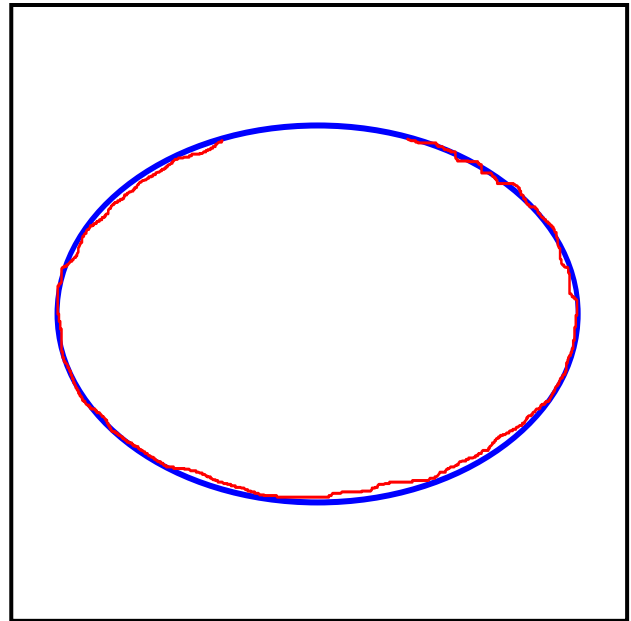
Counter: 180.5 Ft
Code Description: General observation
Remarks: Sonar Scan 1210
Maximum X Restriction 2.14 %
Depth of Debris 0.0766 ft

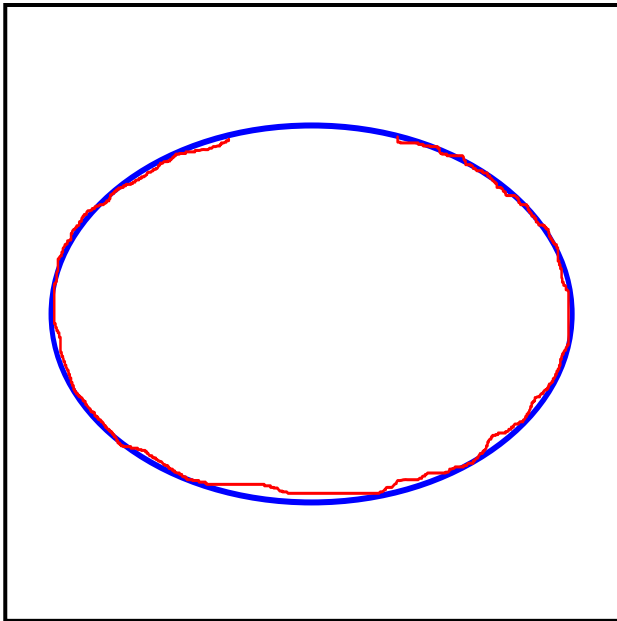
Counter: 202.8 Ft
Code Description: General observation
Remarks: Sonar Scan 1212
Maximum X Restriction 2.94 %
Depth of Debris 0.1054 ft

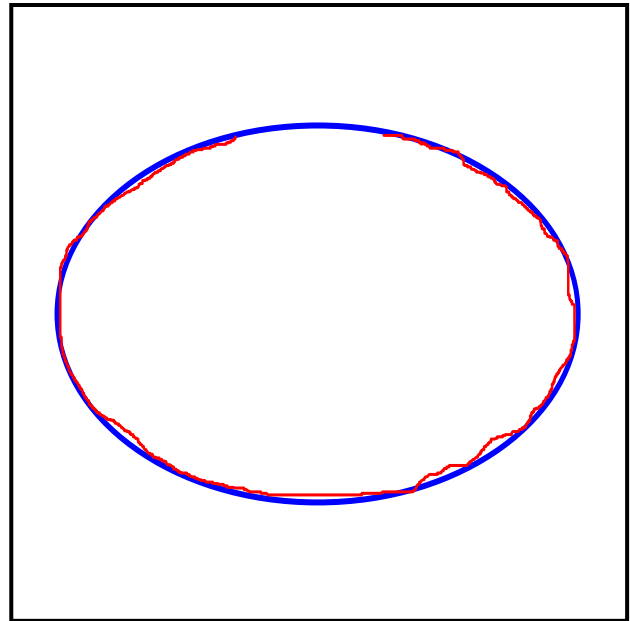
Counter: 222.1 Ft
Code Description: General observation
Remarks: Sonar Scan 1214
Maximum X Restriction 1.87 %
Depth of Debris 0.0671 ft

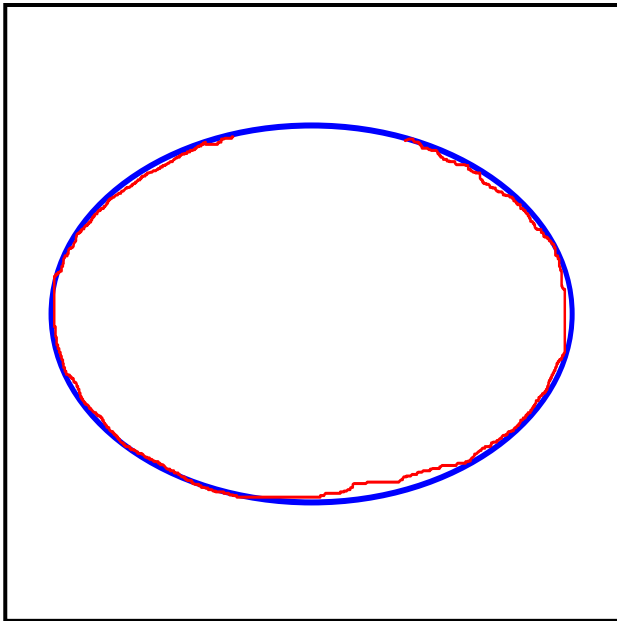
Counter: 241.4 Ft
Code Description: General observation
Remarks: Sonar Scan 1215
Maximum X Restriction 3.21 %
Depth of Debris 0.115 ft

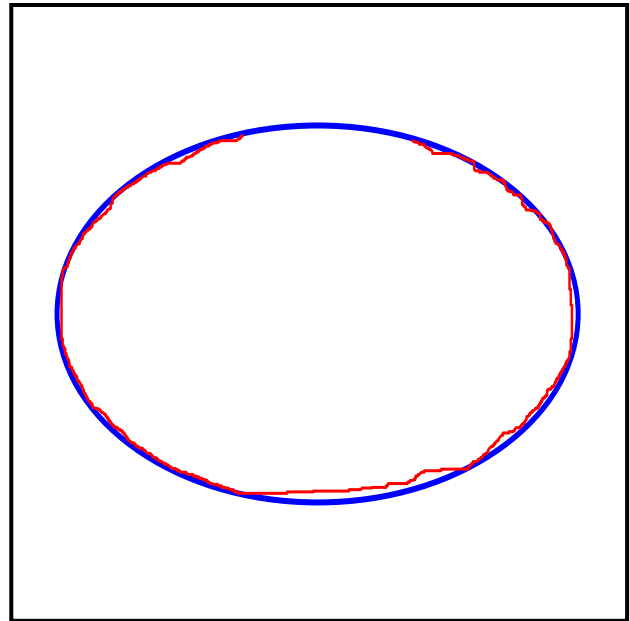
Counter: 262.0 Ft
Code Description: General observation
Remarks: Sonar Scan 1217
Maximum X Restriction 2.67 %
Depth of Debris 0.0958 ft

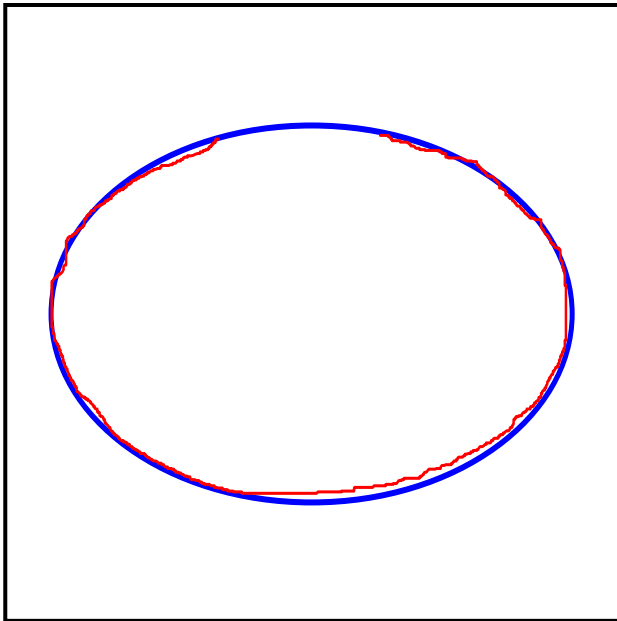
Counter: 278.8 Ft
Code Description: General observation
Remarks: Sonar Scan 1218
Maximum X Restriction 2.67 %
Depth of Debris 0.0958 ft

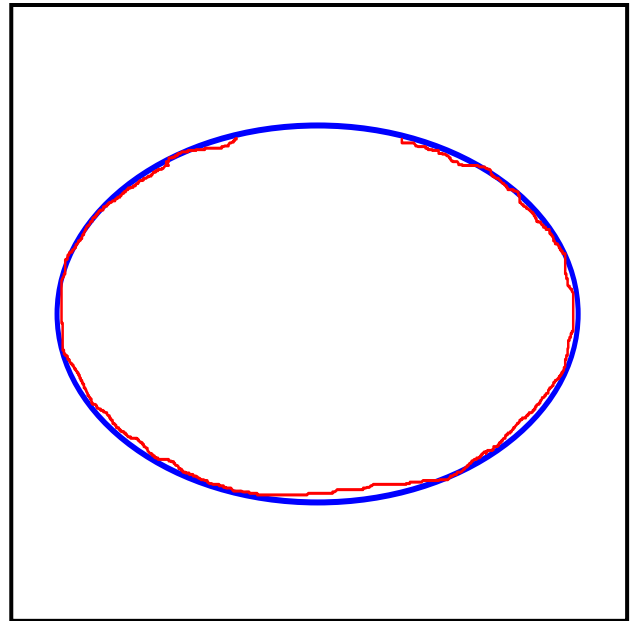
Counter: 299.1 Ft
Code Description: General observation
Remarks: Sonar Scan 1219
Maximum X Restriction 2.94 %
Depth of Debris 0.1054 ft

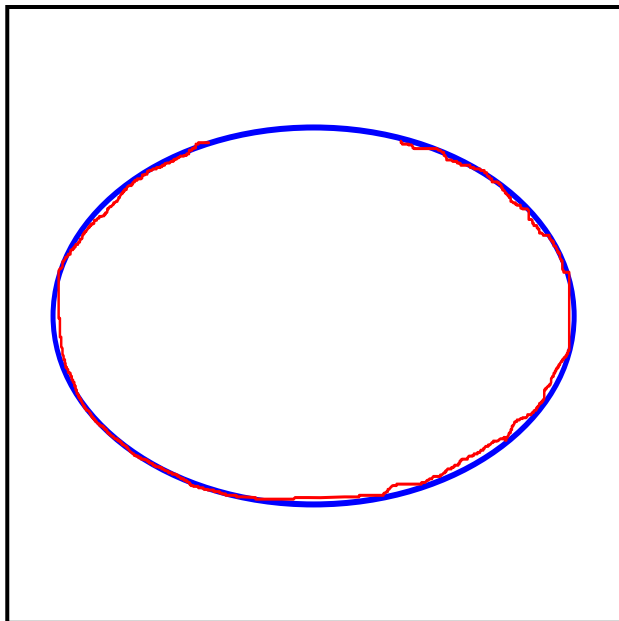
Counter: 320.0 Ft

Maximum X Restriction 1.6 %

Depth of Debris 0.0575 ft

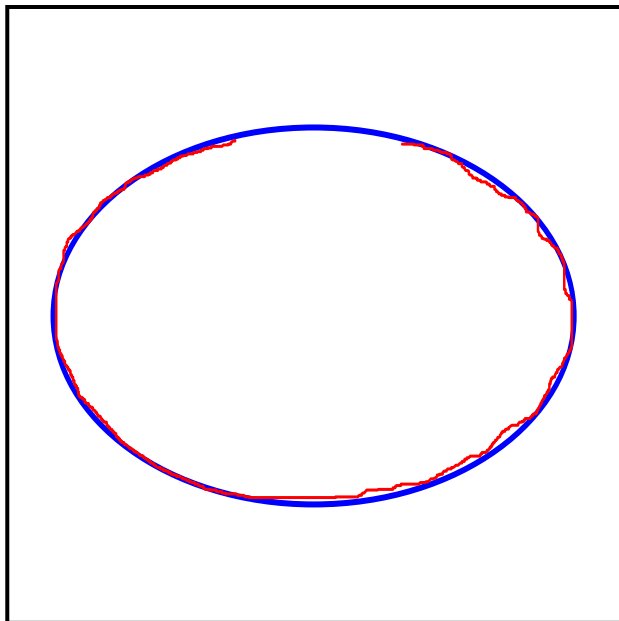
Counter: 365.5 Ft
Code Description: General observation
Remarks: Sonar Scan 1225
Maximum X Restriction 1.6 %
Depth of Debris 0.0575 ft

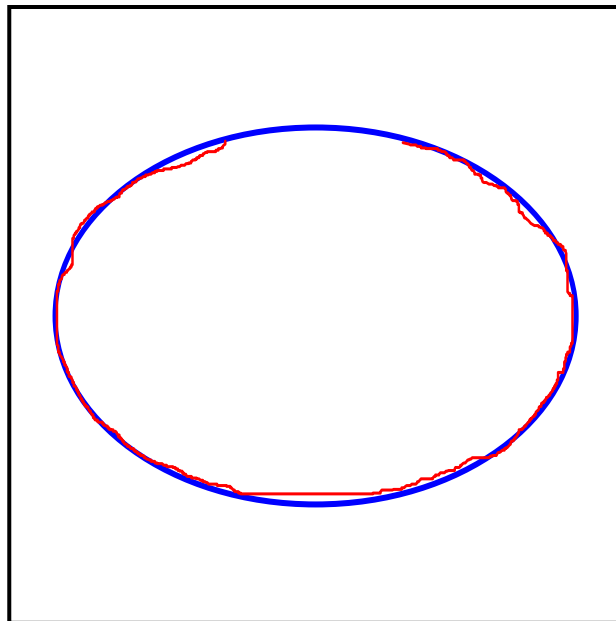
Counter: 367.1 Ft
Code Description: Finish of Surveys
Remarks: J28S-12
Maximum X Restriction 2.67 %
Depth of Debris ft

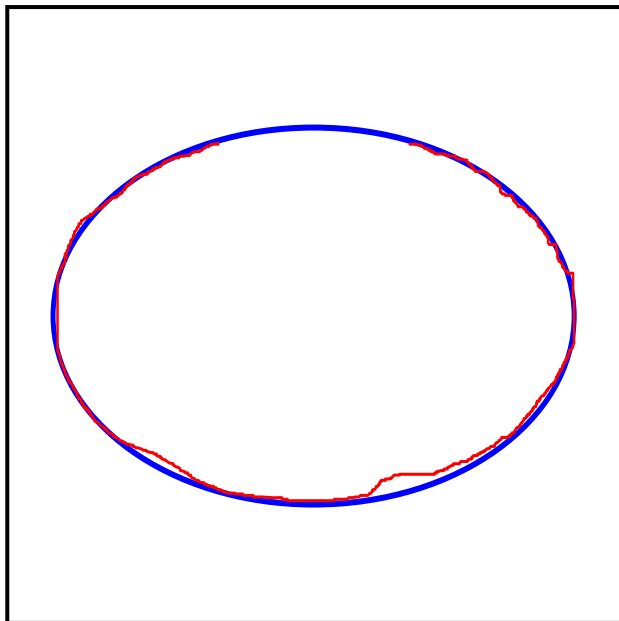
Counter: 0.0 Ft
Code Description: Start of Survey
Remarks: J28S-13_WL-99_Sonar Scan 1420
Maximum X Restriction 2.14 %
Depth of Debris 0.0766 ft

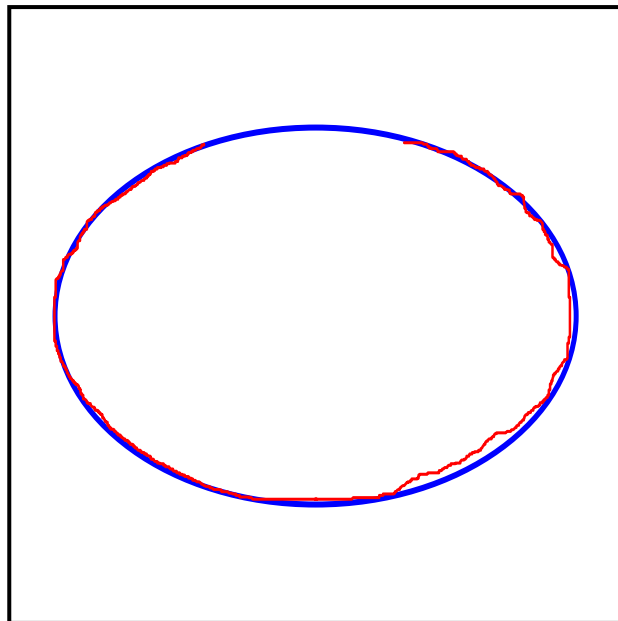
Counter: 19.6 Ft
Code Description: General observation
Remarks: Sonar Scan 1422
Maximum X Restriction 1.34 %
Depth of Debris 0.0479 ft

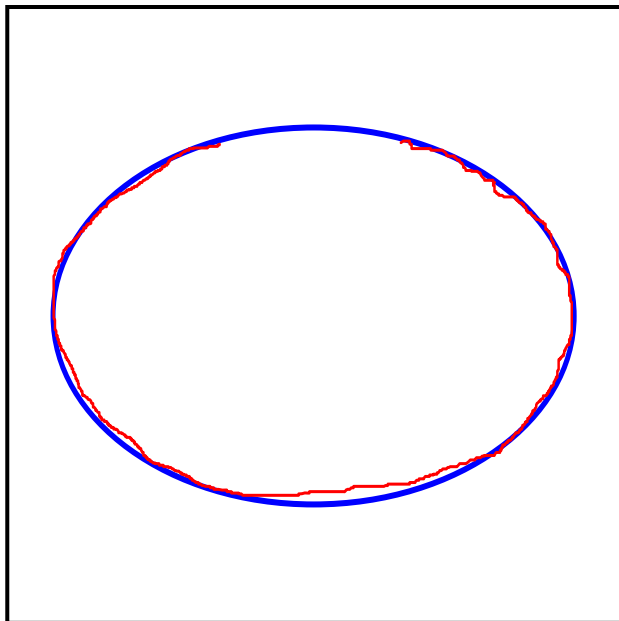
Counter: 39.5 Ft
Code Description: General observation
Remarks: Sonar Scan 1423
Maximum X Restriction 3.21 %
Depth of Debris 0.115 ft

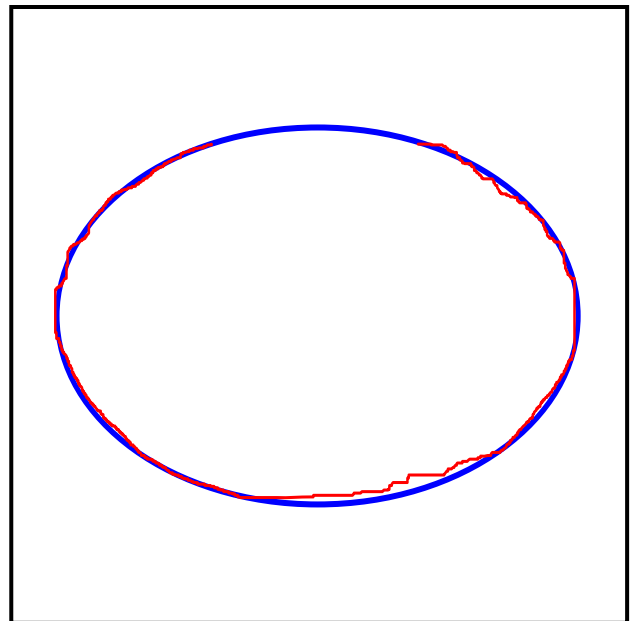
Counter: 60.2 Ft
Code Description: General observation
Remarks: Sonar Scan 1424
Maximum X Restriction 2.14 %
Depth of Debris 0.0766 ft

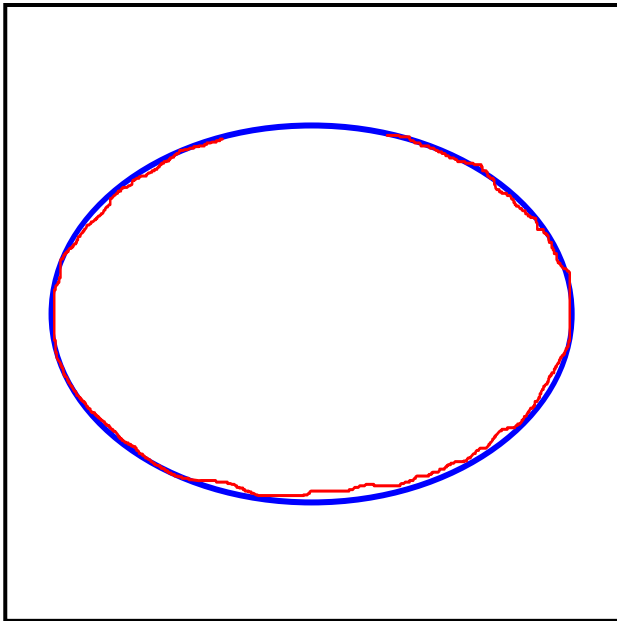
Counter: 79.9 Ft
Code Description: General observation
Remarks: Sonar Scan 1425
Maximum X Restriction 2.94 %
Depth of Debris 0.1054 ft

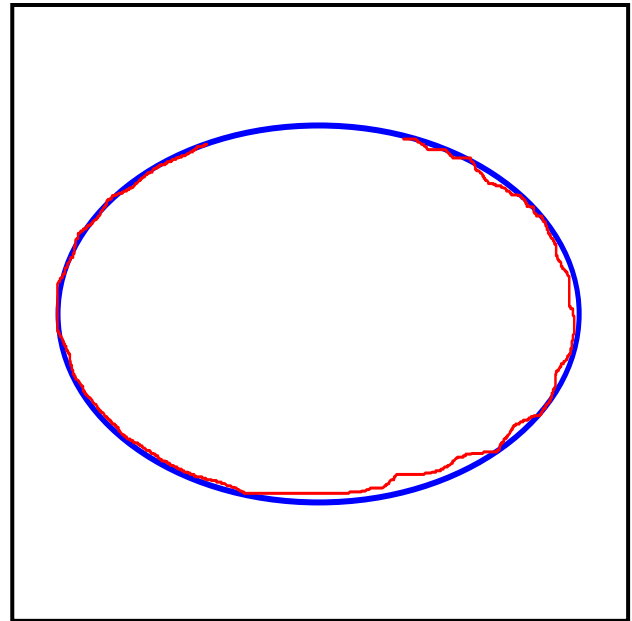
Counter: 100.2 Ft
Code Description: General observation
Remarks: Sonar Scan 1426
Maximum X Restriction 2.14 %
Depth of Debris 0.0766 ft

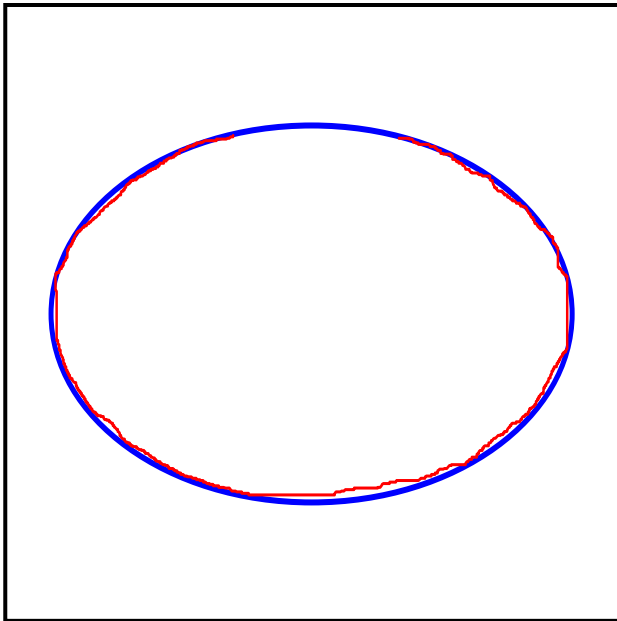
Counter: 119.8 Ft
Code Description: General observation
Remarks: Sonar Scan 1427
Maximum X Restriction 2.14 %
Depth of Debris 0.0766 ft

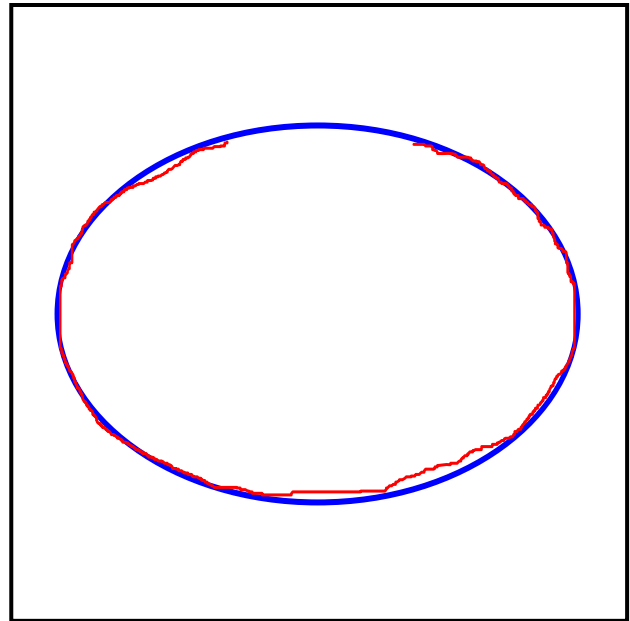
Counter: 140.3 Ft
Code Description: General observation
Remarks: Sonar Scan 1428
Maximum X Restriction 2.67 %
Depth of Debris 0.0958 ft

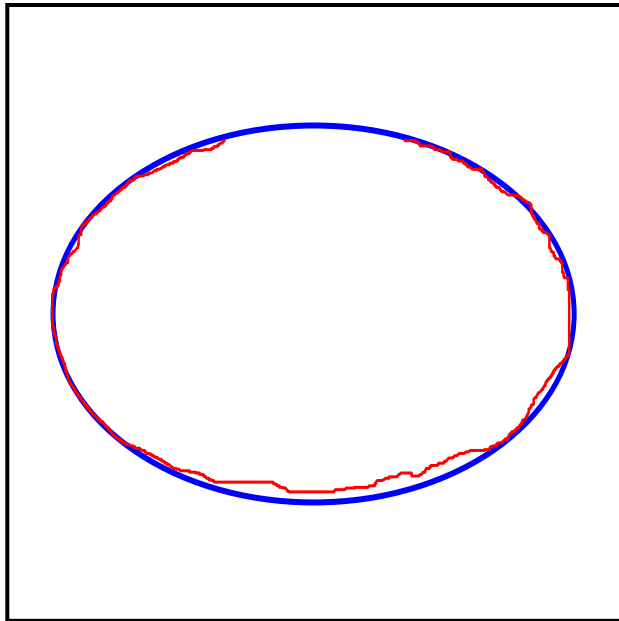
Counter: 160.4 Ft
Code Description: General observation
Remarks: Sonar Scan 1430
Maximum X Restriction 4.01 %
Depth of Debris 0.1437 ft

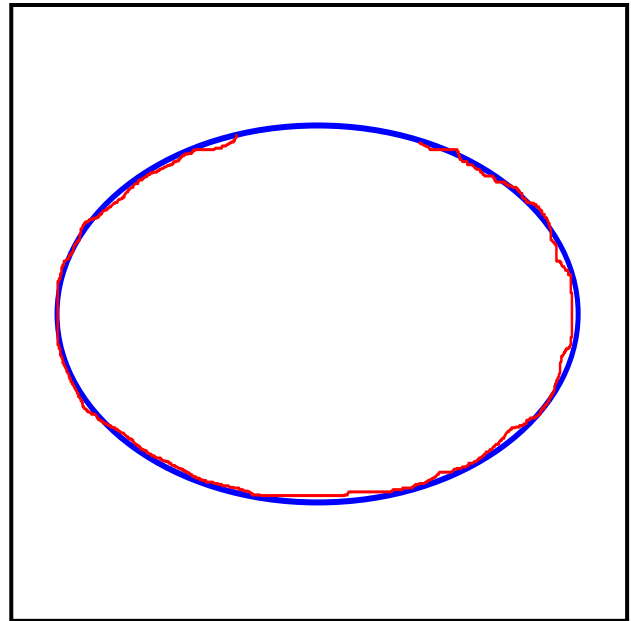
Counter: 180.1 Ft
Code Description: General observation
Remarks: Sonar Scan 1431
Maximum X Restriction 1.87 %
Depth of Debris 0.0671 ft

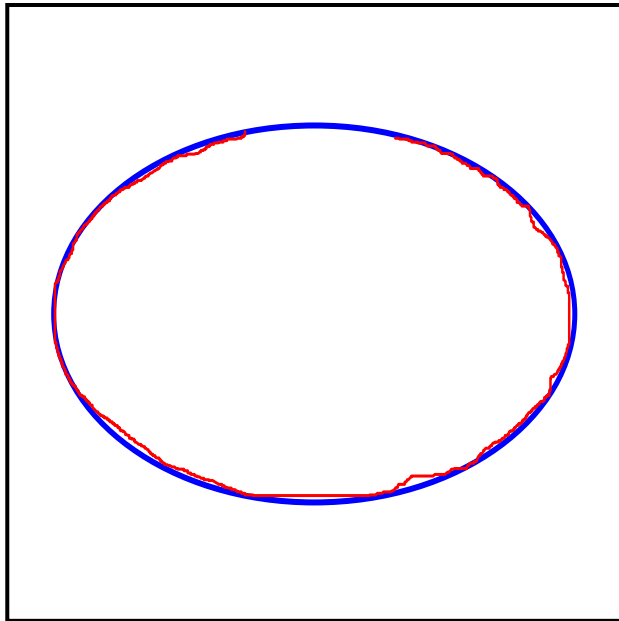
Counter: 200.3 Ft
Code Description: General observation
Remarks: Sonar Scan 1432
Maximum X Restriction 1.6 %
Depth of Debris 0.0575 ft

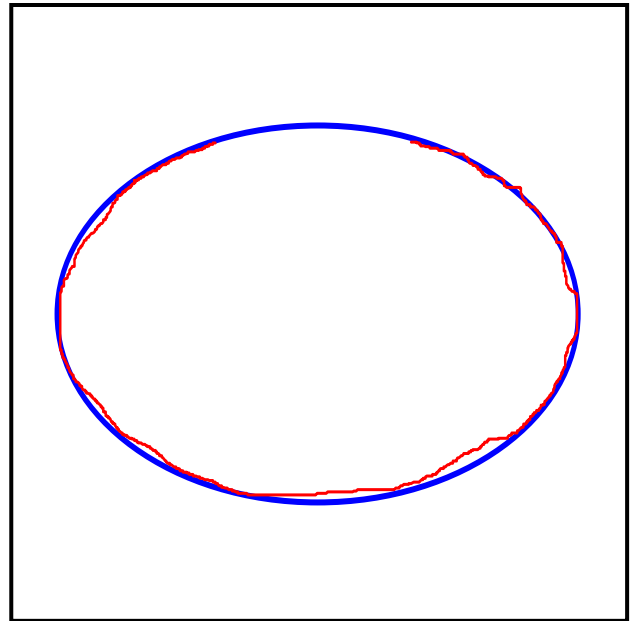
Counter: 220.4 Ft
Code Description: General observation
Remarks: Sonar Scan 1433
Maximum X Restriction 2.67 %
Depth of Debris 0.0958 ft

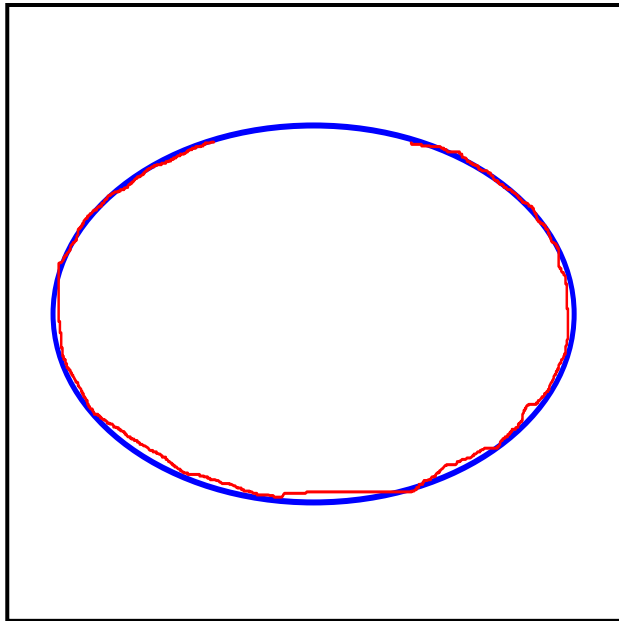
Counter: 239.7 Ft
Code Description: General observation
Remarks: Sonar Scan 1434
Maximum X Restriction 2.67 %
Depth of Debris 0.0958 ft

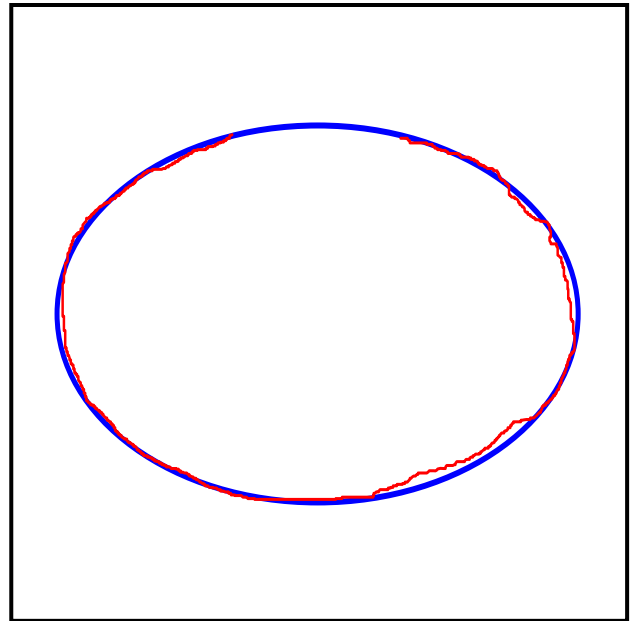
Counter: 259.8 Ft
Code Description: General observation
Remarks: Sonar Scan 1435
Maximum X Restriction 0.53 %
Depth of Debris 0.0192 ft

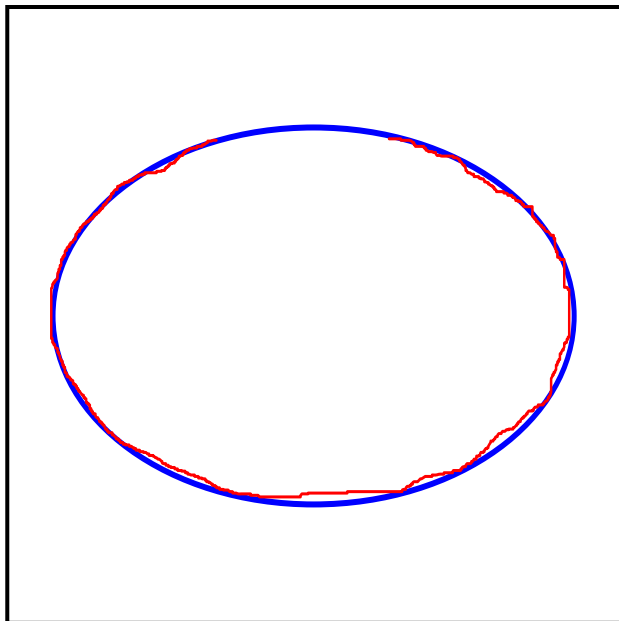
Counter: 280.0 Ft
Code Description: General observation
Remarks: Sonar Scan 1436
Maximum X Restriction 2.94 %
Depth of Debris 0.1054 ft

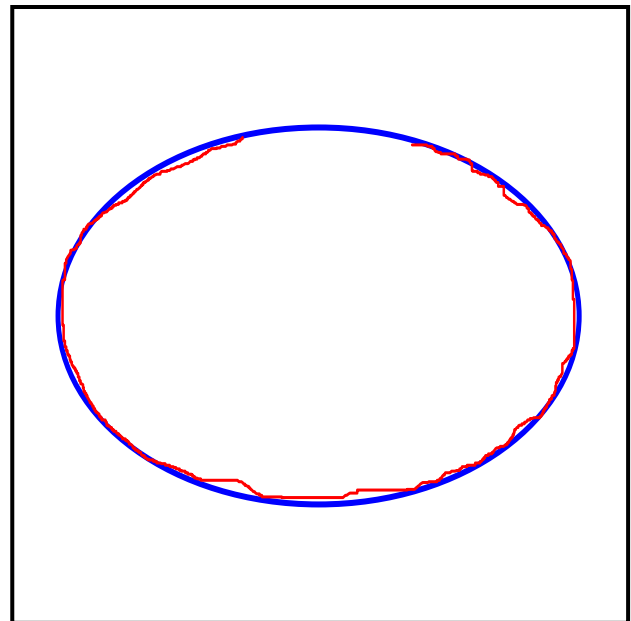
Counter: 300.0 Ft
Code Description: General observation
Remarks: Sonar Scan 1437
Maximum X Restriction 2.41 %
Depth of Debris 0.0862 ft

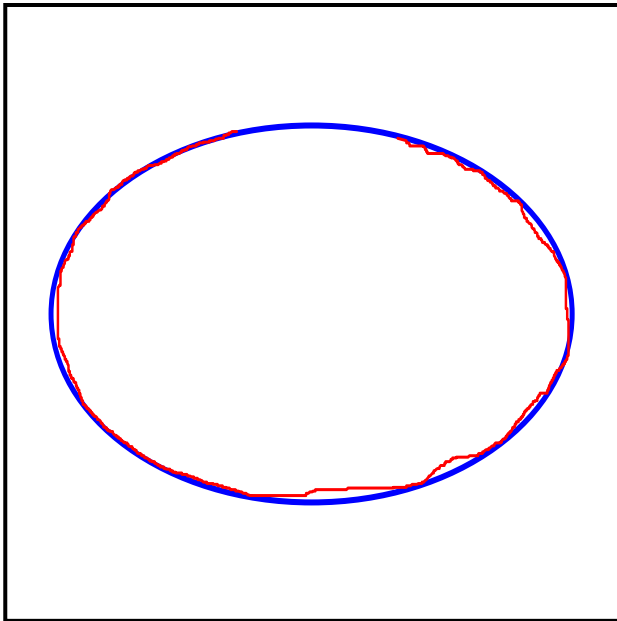
Counter: 320.1 Ft
Code Description: General observation
Remarks: Sonar Scan 1439
Maximum X Restriction 3.21 %
Depth of Debris 0.115 ft

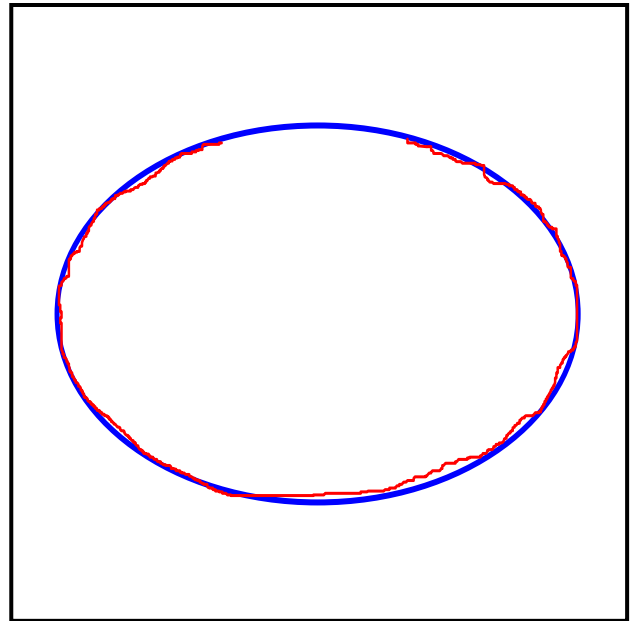
Counter: 339.5 Ft
Code Description: General observation
Remarks: Sonar Scan 1439
Maximum X Restriction 2.14 %
Depth of Debris 0.0766 ft

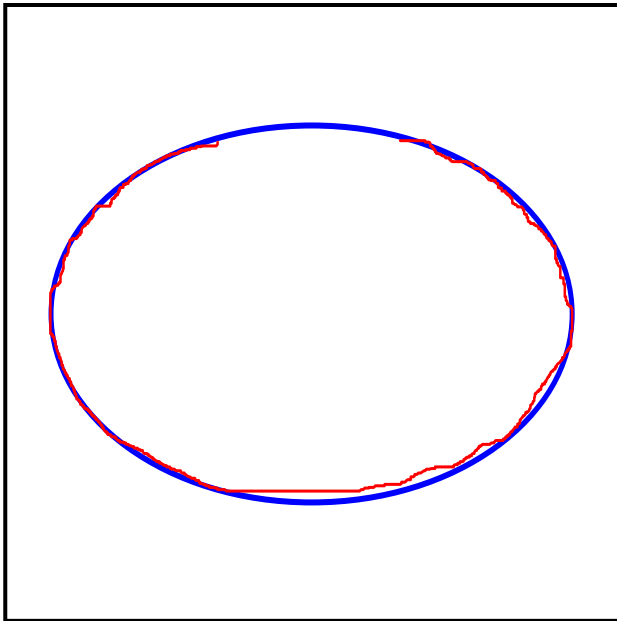
Counter: 360.5 Ft
Code Description: General observation
Remarks: Sonar Scan 1441
Maximum X Restriction 2.94 %
Depth of Debris 0.1054 ft

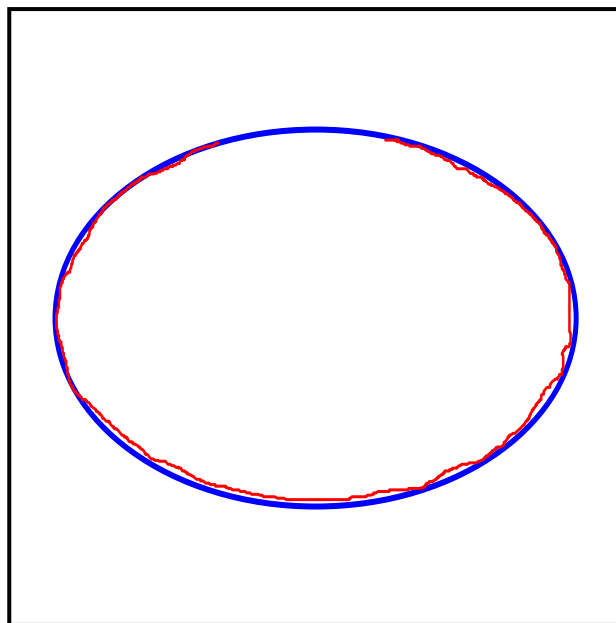
Counter: 20.6 Ft
Code Description: General observation
Remarks: Sonar Good Condition 1007
Maximum X Restriction 1.6 %
Depth of Debris 0.0575 ft

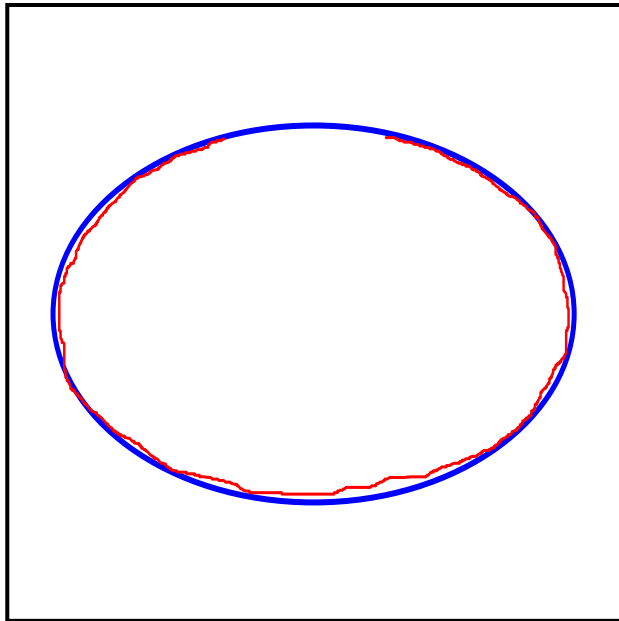
Counter: 81.0 Ft
Code Description: General observation
Remarks: Sonar Good Condition 1011
Maximum X Restriction 2.94 %
Depth of Debris 0.1054 ft

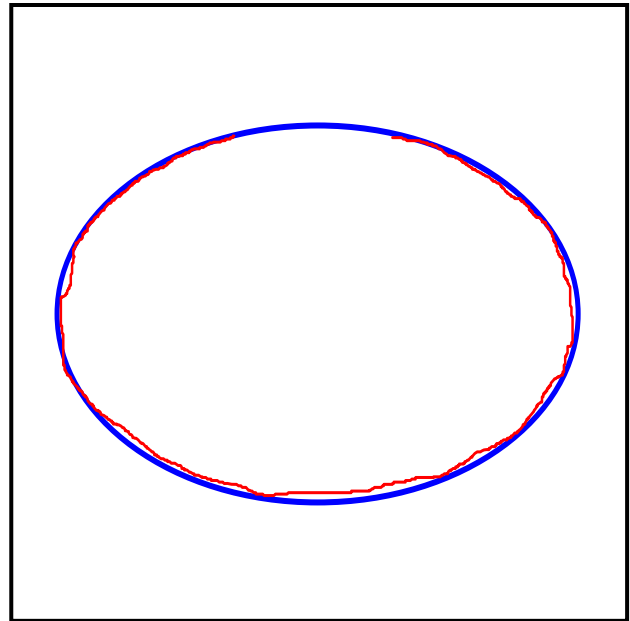
Counter: 101.9 Ft
Code Description: General observation
Remarks: Sonar Good Condition 1012
Maximum X Restriction 2.41 %
Depth of Debris 0.0862 ft

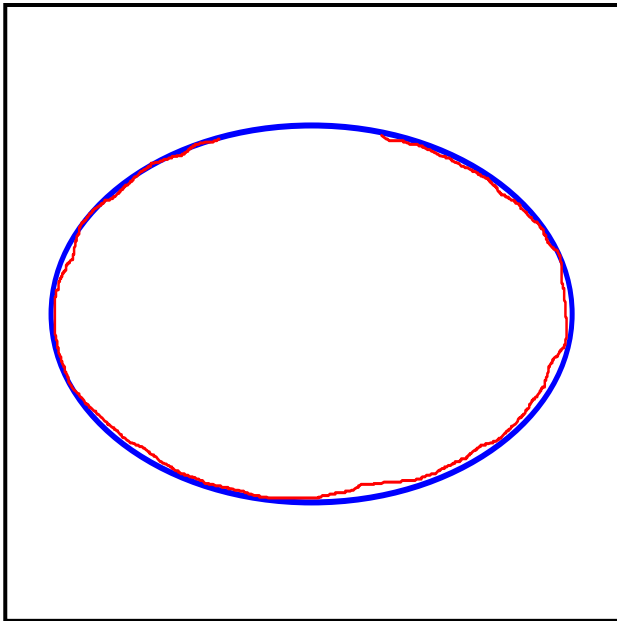
Counter: 120.6 Ft
Code Description: General observation
Remarks: Sonar Good Condition 1013
Maximum X Restriction 2.67 %
Depth of Debris 0.0958 ft

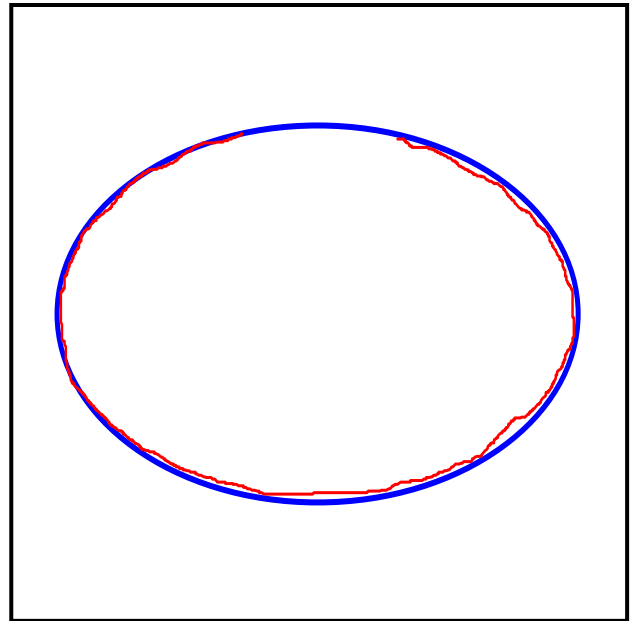
Counter: 141.5 Ft
Code Description: General observation
Remarks: Sonar Good Condition 1014
Maximum X Restriction 2.41 %
Depth of Debris 0.0862 ft

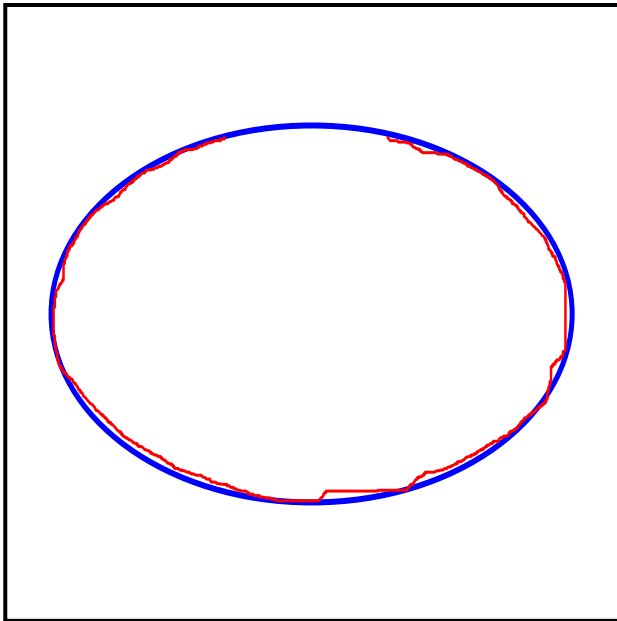
Counter: 160.8 Ft
Code Description: General observation
Remarks: Sonar Good Condition 1015
Maximum X Restriction 2.67 %
Depth of Debris 0.0958 ft

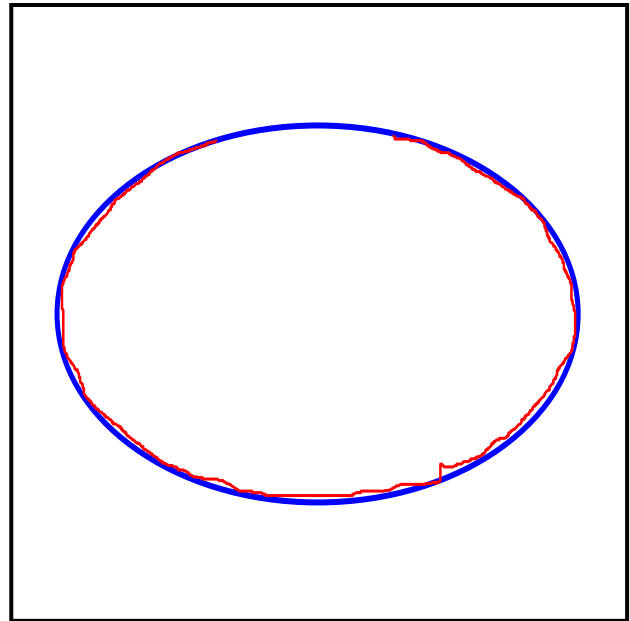
Counter: 180.7 Ft
Code Description: General observation
Remarks: Sonar Good Condition 1016
Maximum X Restriction 1.6 %
Depth of Debris 0.0575 ft

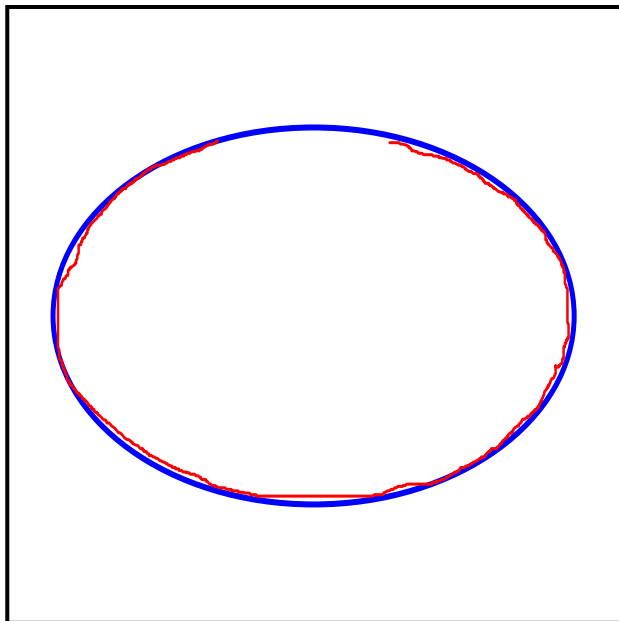
Counter: 199.3 Ft
Code Description: General observation
Remarks: Sonar Good Condition 1017
Maximum X Restriction 2.14 %
Depth of Debris 0.0766 ft

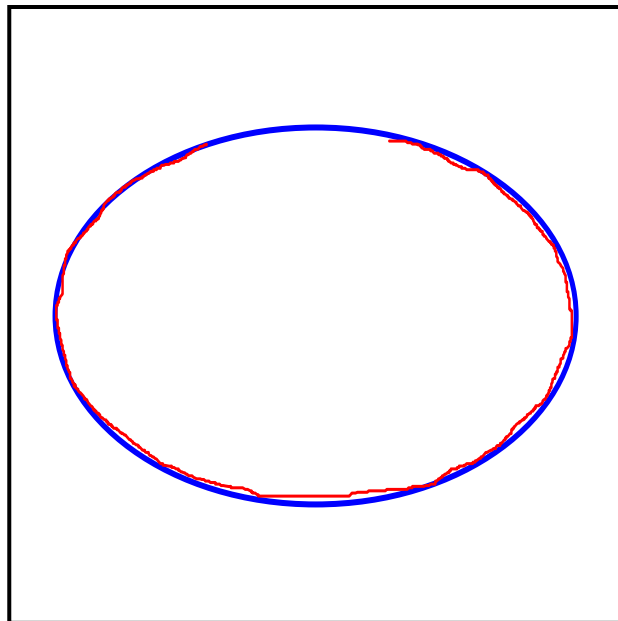
Counter: 220.4 Ft
Code Description: General observation
Remarks: Sonar Good Condition 1018
Maximum X Restriction 2.14 %
Depth of Debris 0.0766 ft

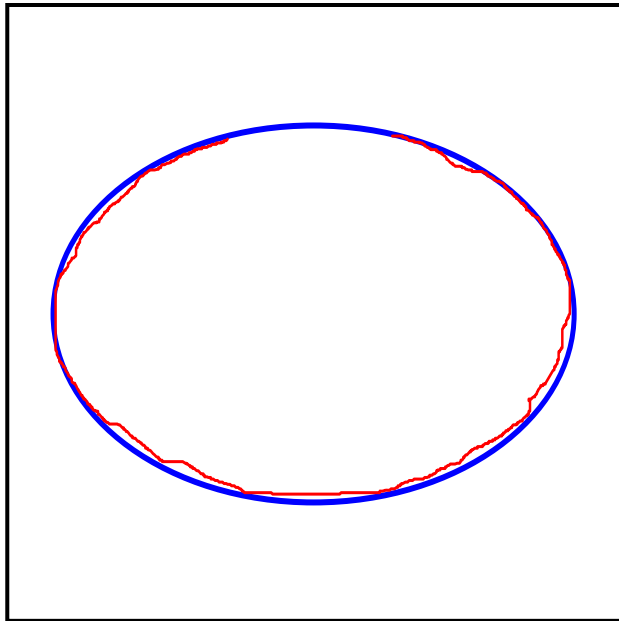
Counter: 360.9 Ft
Code Description: General observation
Remarks: Sonar Good Condition 1025
Maximum X Restriction 2.14 %
Depth of Debris 0.0766 ft

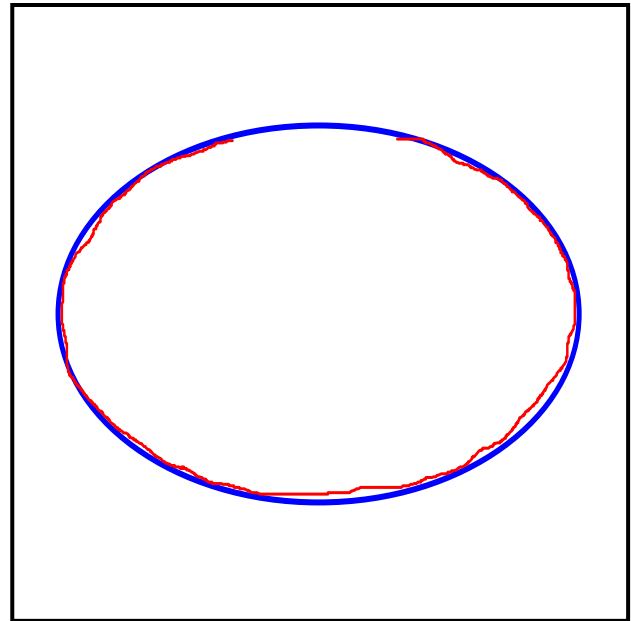
Counter: 380.9 Ft
Code Description: General observation
Remarks: Sonar Good Condition 1026
Maximum X Restriction 2.41 %
Depth of Debris 0.0862 ft
