Special Meeting of the Metro Commission and Metro Wastewater JPA

- X 4. **ACTION:** CONSIDERATION AND POSSIBLE ACTION TO APPROVE THE MINUTES OF THE REGULAR MEETING OF [October 1, 2020](#) (**Attachments**)
- X 5. **PRESENTATION:** SUMMARY OF APRIL 10, 2020 CITY OF SAN DIEGO SANITARY SEWER OVERFLOW INCIDENT (Tom Rosales/Dean Gipson HDR) (**Attachment**)

Subject: Notice of Violation No. R9-2020-0204 and Investigative Order No. R9-2020-0205 for the Reported April 10, 2020 Unauthorized Discharge to Sweetwater River - Written Responses

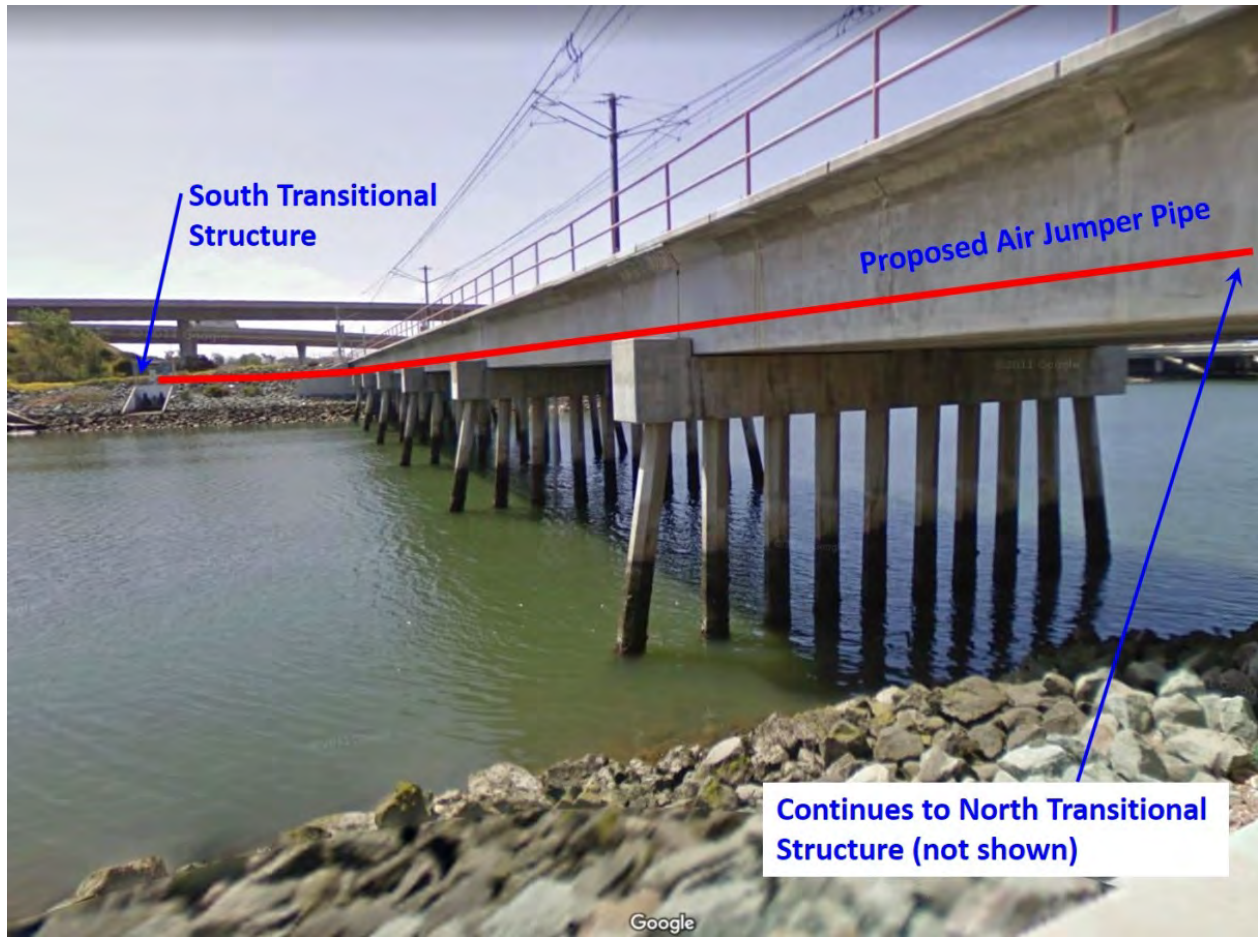
Figure 9. Proposed Routing for the Air Jumper Pipe

- Selecting the right size requires field data
- Routing of the air jumper in this location will be challenging because of the limited crossing options
- Difficult and high construction costs
- Some maintenance and regular inspections will be required
- Difficult permitting process

This passive solution requires some maintenance, no downtime, no chemicals, and no additional utilities. An air jumper is a pipe that could be installed across the river and connect the two structures. An air jumper will create a passage for the air to pass from the south structure (FSN 113189) to the north structure (FSN 113188) and continue to flow downstream along with the wastewater. The pipe size will depend on the air flow and available pressure. The pipe may be constructed of chlorinated polyvinyl chloride pipe to eliminate corrosion issues. A feasibility study is recommended to pursue this option further. Based on preliminary findings, routing the air jumper pipe via the San Diego Metro Transit System Blue Line Bridge may be the best possible option (Figure 9).

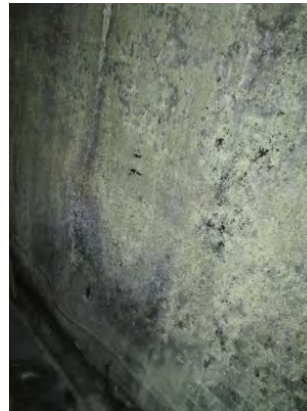
View of seam and bubbles on vertical wall in main structure.

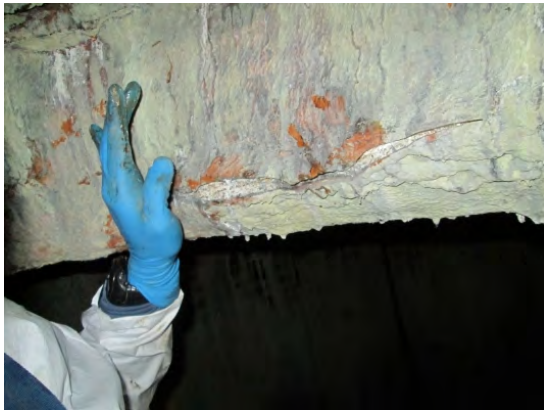
View of cuts in liner at bottom of short barrel section in manhole.
